**Common Area Building Survey Report  
Of**

**Levels P1 – Roof** (external of private lots)

**Elizabeth Bay**

**Strata Plan No XYZ**

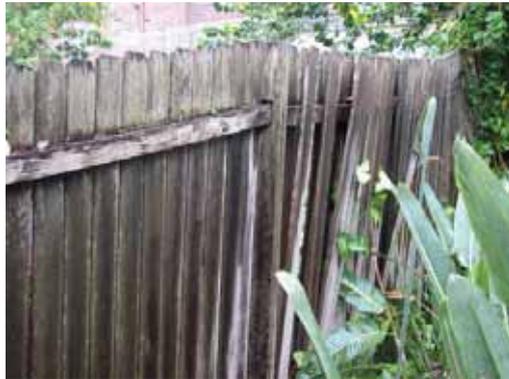
*Photo No 1*

*Defects; Fences; Refer Photo No1* of the *eastern boundary paling fence*, which has significant soft rot and is dilapidated. This fence serves as a safety isolating fence to the adjoining property and the O.C public liability could be at risk should a child gaining entry into the subject pool area.

**Priority Level 3; Recommend** replacement of dilapidated *eastern paling fence* before complete collapse.

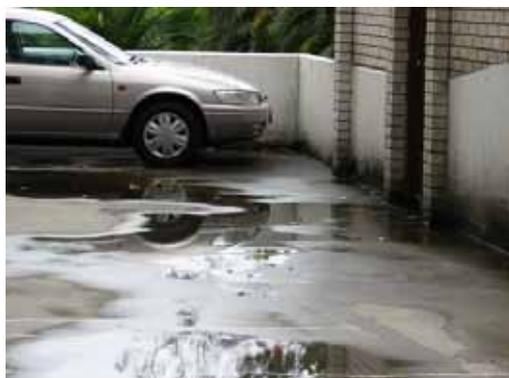
*Photo No 15*

**Photo No15** shows how excess *surface water pools* on P2 slab above due to inadequate drainage (as small drainage pipe is set higher than floor level).

**Priority Level 2;** upon improving surface drainage in P1 & P2 areas monitor moisture penetration through slab.

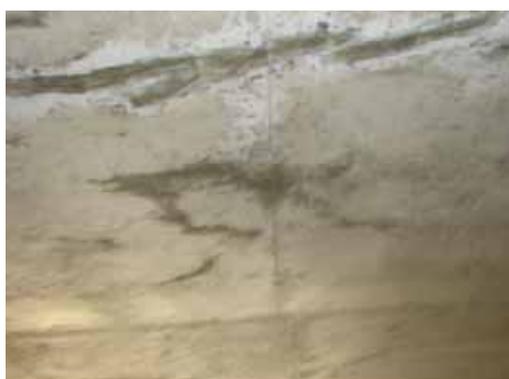
*Photo No 16*

**Damp\leakages; Refer example Photo No16** showing evidence of *moisture penetration* (via staining) at the *eastern slab soffit*, which is located beneath the above noted exposed and poorly drained area of P2 slab where excess surface water was pooling.

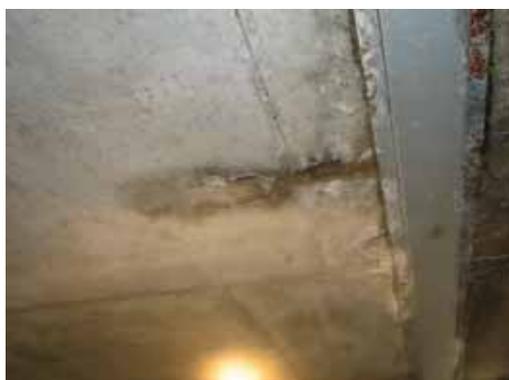
*Photo No 18*

**Refer example Photo No18** showing evidence of *moisture penetration* (via staining) at the northern slab soffit, beneath P2.

This area recorded moderate to high moisture content when tested with a moisture meter.

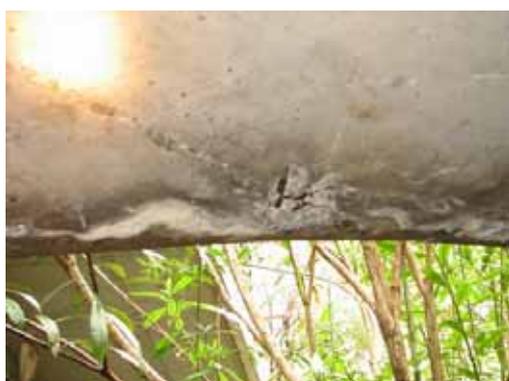
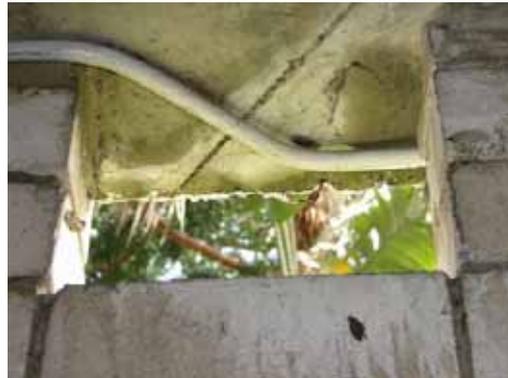
*Defects; Damp\leakages; Refer Photos No19 & 20* showing evidence of minor to *moderate moisture related spalling* and efflorescence to the *driveway slab edge*, which does not incorporate a drip groove, on either side.

In my professional opinion most of the noted spalling and efflorescence is being caused by surface water run-off (predominantly caused by inadequate drainage) and capillary water tracking due to lack of drip grooves.

**Priority Level 2; Recommend** that structural engineer inspect the noted spalling and provide recommendations as to any remedial works.

Recommend that *continuous drip grooves* be formed near both the internal and external edges of all noted exposed concrete slabs, subject to confirmation by a structural engineer.

**Priority Level 2; Recommend** undertake concrete spalling remedial works as required by structural engineer.

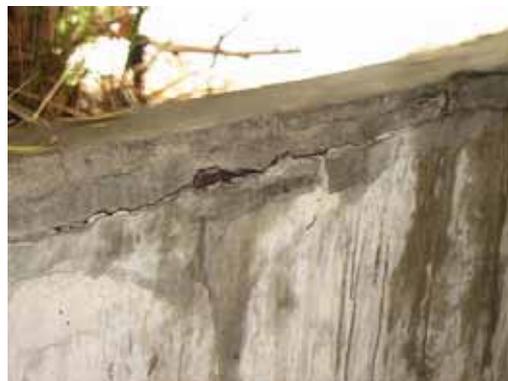
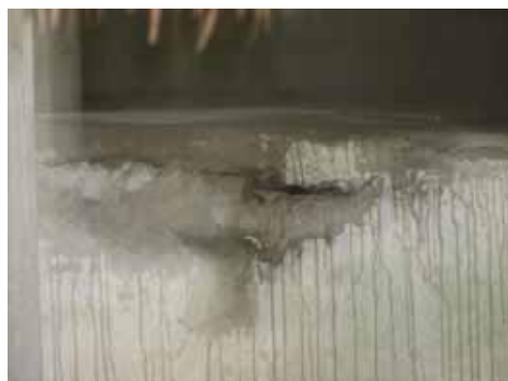
*Refer Photo No21 & 21A* showing evidence of *moderate* moisture related *concrete spalling* and cracking to the upper driveway *concrete balustrade wall*, adjoining *column and slab*, where some settlement cracking has occurred. *Refer Photo No22* showing evidence of *moderate* moisture related *concrete spalling* to the slab soffit at upper driveway, adjacent to recently installed P2 stormwater drain.

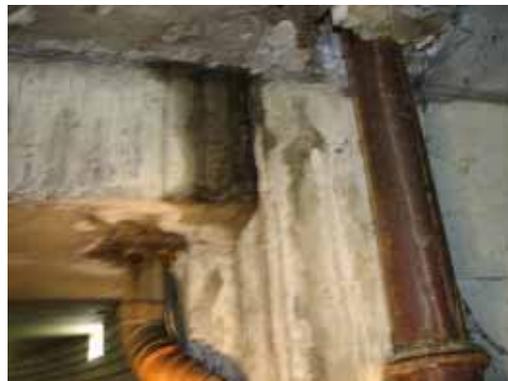
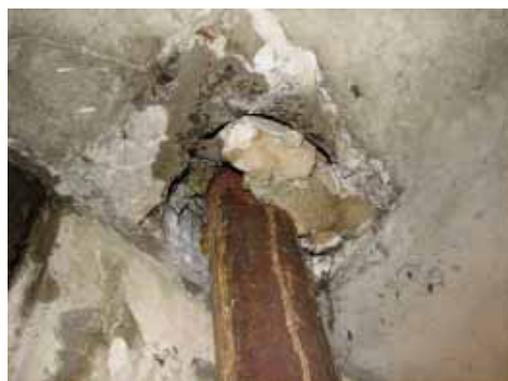
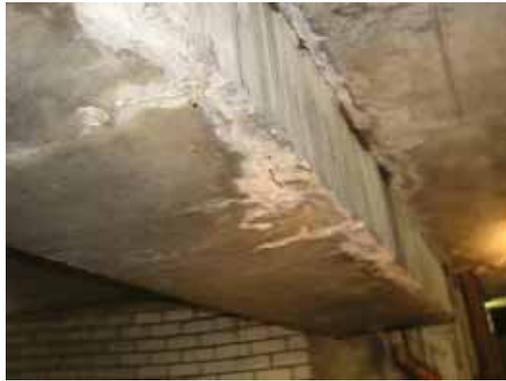
*Refer Photos No23, 23A & 23B* showing evidence of *moderate* moisture related *concrete spalling* and cracking to the lower driveway slab soffit, drop beam and adjoining column, where some cracking has occurred.

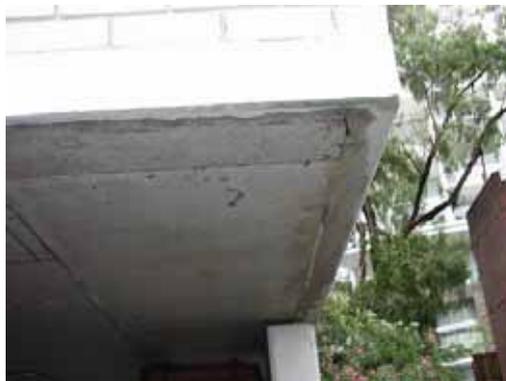
*Photo No 24*

*Refer Photo No24* showing a *lack of drip groove* to the external corner slab soffit a western end of P1, the lack of which is allowing capillary related moisture tracking and which may lead to *concrete spalling*.

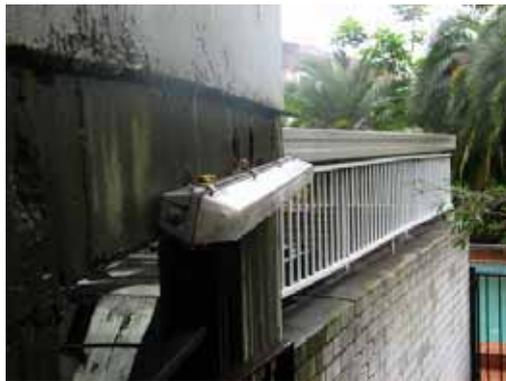
*Photo No 25*

*External light fitting Refer Photo No25* showing an *external fluro light fitting*, which is loose and surface water run-off is discharging into the area behind light fitting presenting a possible electrical hazard.

In my professional opinion I consider that excess *surface water run-off* from the previously noted inadequately drained *P2 NE carpark* is causing most of the surface rust and promoting the electrical hazard.

**Priority Level 2;** Rectify water entry behind external fluro light fitting, which is loose as presenting a possible electrical hazard and Refer 3.1A Recommendations.

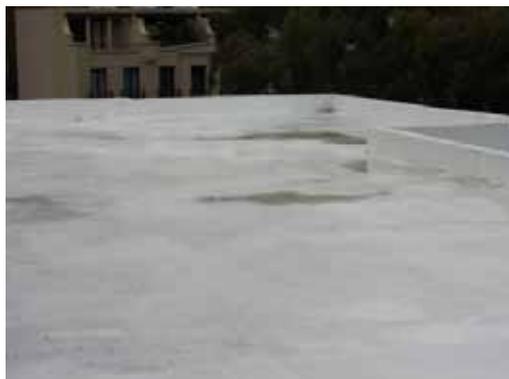
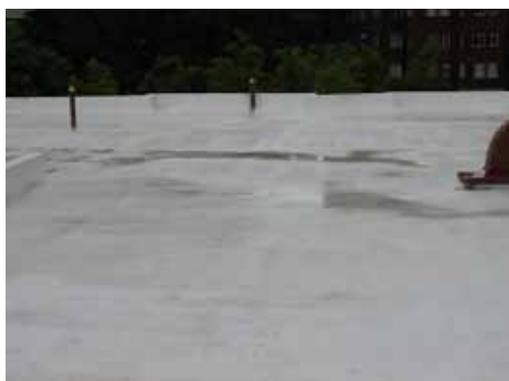
*Defects; significant ponding of water* was occurring on the roof slab in various locations, including SW, SE and NW corners. *Refer example Photos No70 and 71.*

In my professional opinion the noted falling damp within unit 8D is directly as a result of either a non-existent or defective roof membrane, I do not consider that an effective waterproof membrane exists on the main roof and a number of other defects have become evident as a result of the lack of same, as follows; *Refer example Photo No76 & 77* showing evidence of *spalling* of the roof slab, which I consider, has occurred due to a defective roof membrane and the very high moisture content that would be evident within the concrete slab beneath.

**Priority Level 1; Recommend a new roof membrane** is installed over entire main roof and the lift shaft roof as per the following suggestions;

- (1) Install *fall arrest anchors* in accordance with the minimum requirements of OH&S.
- (2) All existing spalling and drummy topping be rectified and the roof topped so as to prevent or minimize ponding or pooling.
