Purpose of Report: *Post Renovation Building Defects Report*
Date of Inspection: 17th October 2005
Property Description: **4-5 Bed F.S Timber Framed Residence**
Address of Property: **Burrawang NSW**
Invoice No.
Client Name: Mr & Mrs. M
Building Consultant: Mr. Dominic Ogburn AMAIB Lic No BC 359
e-mail: info@accesspropertyservices.com.au
Office (02) 9798 5000 Fax (02) 9225 9656 Mobile 0418 865-663

On behalf of the client **Mr/s. M & L. M** I undertook a building survey of the subject **property** over one third of a day on **17/10/05**.

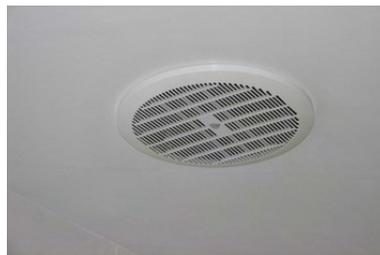
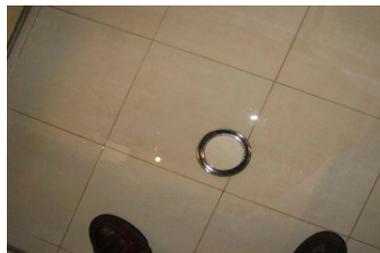
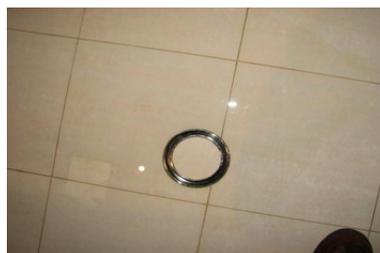
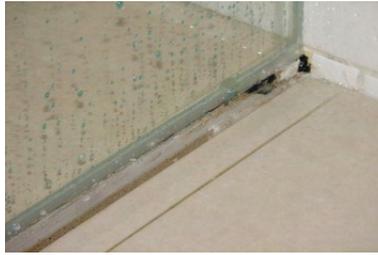
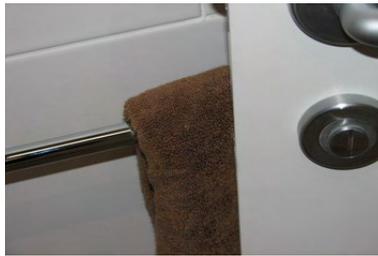
In my professional opinion the roof void is essentially a sealed space and the intent of the BCA for non naturally ventilated bathrooms has not been met, as the mechanical exhaust should be ducted to the outside, to prevent condensation and moisture buildup within the roof void.

Vanity cupboard; the polyurethane finished vanity cupboard doors and drawers do not incorporate any rubber buffers, as per good building practice, and this may result in impact related damage to the finish.

In my professional opinion I do not consider the vast majority of tile joints incorporate adequate expansion provision and it is possible over an extended period of time that the lack of same could lead to partial tile delamination and/or cracking.

Builder to remove and reinstate shower recess so that the minimum requirements of A.S. 3740 – 2004 for floor falls and set down are achieved and that a revised warranty certificate be provided. If the builder fails to comply, take-up issue with the project PCA.

Vanity cupboard; recommend clear rubber buffers be installed on all drawers and doors.

Notwithstanding this it is my professional opinion that such sealant filled joints should be installed. In the alternative I recommend tiles be monitored for future cracking and/or delamination

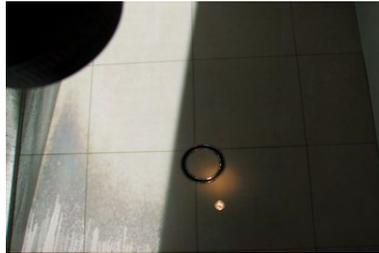
Photo No 6

Vanity cupboard; the polyurethane finished vanity cupboard doors and drawers do not incorporate any rubber buffers, as per good building practice, and this may result in impact related damage to the finish.

In my professional opinion I do not consider the vast majority of tile joints incorporate adequate expansion provision and it is possible over an extended period of time that the lack of same could lead to partial tile delamination and/or cracking.

Vanity cupboard; recommend clear rubber buffers be installed on all drawers and doors.

In the alternative I recommend tiles be monitored for future cracking and/or delamination

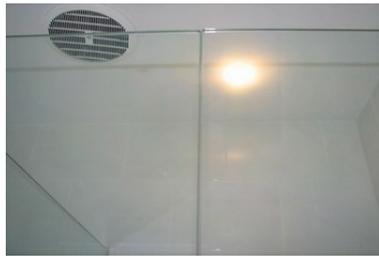
Photo No 7

Shower screen; the toughened glass shower screen door impacts slightly against the adjoining fixed panel at the upper section during closure – *Refer example Photo No7* and which could lead to impact related fracture.

Shower Screen; builder to adjust and/or replace shower screen doors as to prevent impact against adjoining panels and to create even gap margins.

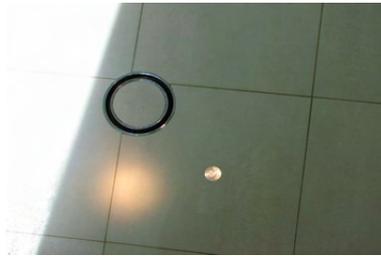
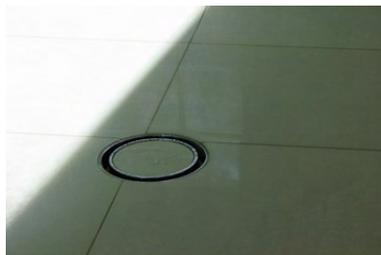
Vanity cupboard; the polyurethane finished vanity cupboard doors and drawers do not incorporate any rubber buffers, as per good building practice, and this may result in impact related damage to the finish.

In my professional opinion I do not consider the vast majority of tile joints incorporate adequate expansion provision and it is possible over an extended period of time that the lack of same could lead to partial tile delamination and/or cracking.

Builder to remove and reinstate shower recess so that the minimum requirements of A.S. 3740 - 2004 for floor falls and set down are achieved and that a revised warranty certificate be provided. If the builder fails to comply, take-up issue with the project PCA.

Vanity cupboard; recommend clear rubber buffers be installed on all drawers and doors.

Notwithstanding this it is my professional opinion that such sealant filled joints should be installed.

In the alternative I recommend tiles be monitored for future cracking and/or delamination

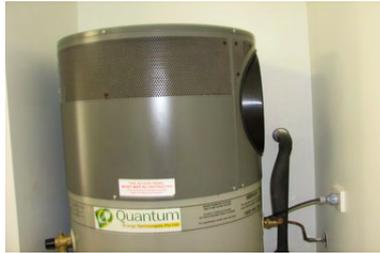
Photo No10

Operative noise; In my professional opinion and as advised by John Payne' this operative noise is the equivalent to and/or greater than many external air-conditioning units and in my opinion the operative noise of the HWS is quite significant and intrusive.

I consider the operating noise to be unacceptably high including seeming vibrational noise as generated by the partially loose water supply and condensate lines, which penetrate through enclosing timber framed walls and which I'm advised are not acoustically insulated.

Installation; the *water supply and condensate overflow pipes* have not be adequately secured or isolated to prevent vibrational noise and are in my professional opinion contributory to the amount unacceptable of noise generated and are contrary to Contract Specification clause 14.3 General as previously noted.

I consider the builder is substantially liable and **recommend** the hot water service be removed and replaced with the specified *Quantum* model 340 T2S in accordance with the manufacturers minimum installation requirements and in an agreed external location (possibly outside Garage) and as close as possible to usage points. All hot water service pipe work should be adequately secured and free from vibration, the condensate line should be connected to a waste tundish.

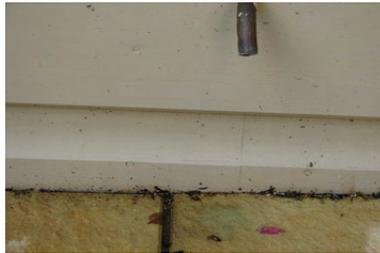
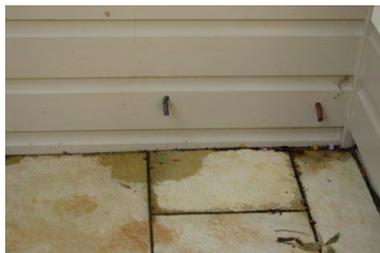
Refer Photos No11 & 11A showing the hot water service *condensate lines* inappropriately discharging onto entry patio paving, which is partially in contact with the lower external timber wall cladding and is promoting moisture gain within the cladding and which could lead to soft rot deterioration. Refer also Section 7A of this report for further comment.

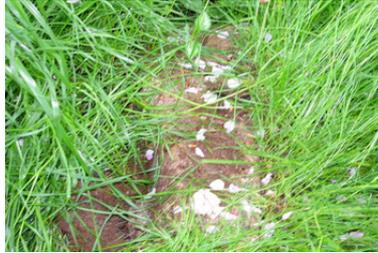
Photo No23

I'm advised by the owners that the builder had only broken up the concrete as recent rains have uncovered the walls of the tank - *Refer Photo No23*.

Original Septic tank; I **recommend** that the builder is to remove all remnants of the original septic tank from site and make good the surrounding soil.
