Purpose of Report: Standard Pre Purchase Property Inspection
Date of Inspection: 11.11.05
Property Description: 2 Bed 1st Flr Unit
Address of Property: Warners Av BONDI
Invoice No.
Client Name: Mr AR C/- Paddington NSW 2021
Building Consultant: Building Consultant Dominic. J. Ogburn AMAIB Lic No BC 359
e-mail: info@accesspropertyservices.com.au
Office (02) 9798 5000 Fax (02) 9225 9656 Mobile 0418 865-663

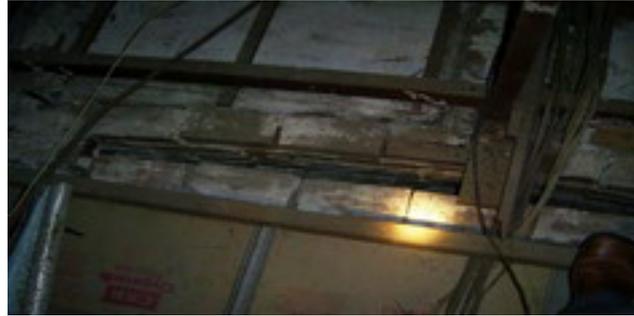
Photo No3

Unit entry door wall; very significant rotational movement evident between the two wall leaves, as seen from the roof void above (*Refer example Photo No3*)

I **recommend** that a qualified structural engineer should be sought for a precise assessment of probable cause and remedial works.

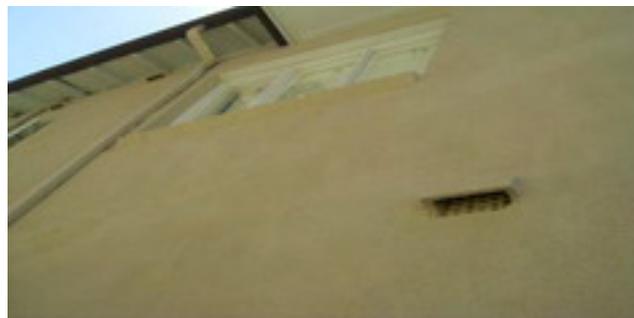
Photo No4

External Walls; evidence of moderate to severe prior filled cracking in the forward upper eastern and western external walls (*Refer example Photo No4*)

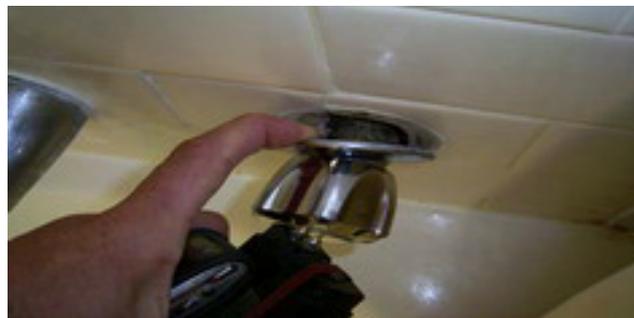
Moderate moisture readings were recorded in the eastern enclosing shower wall (as measured within the linen cupboard), which is probably associated with the fact that the *shower tap penetrations* had not been sealant filled – *Refer Photo No5*

Noted Defects; evidence of damp noted within the adjoining linen cupboard, which I believe is associated with unsealed *shower tap penetrations* – Refer example Photo No5 – rectify by sealant filling.

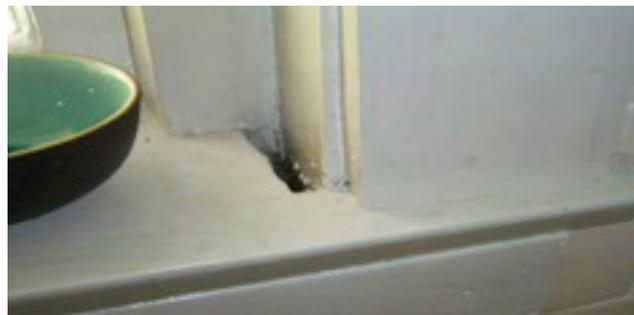
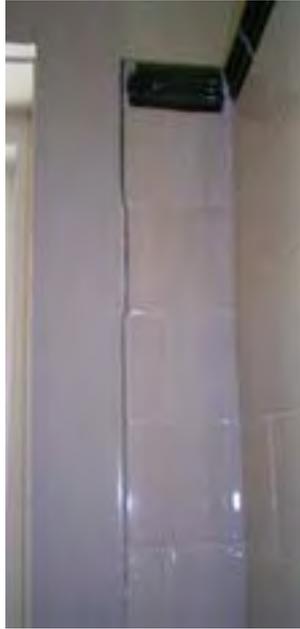
Photo No6

No notable defects recorded other than a very significant prior movement related gap evident in the *Bathroom sill\frame & wall tiling - Refer example Photos No6 & 6A.*
