Purpose of Report: *Special Purpose (Damp) Partial Inspection Report*
Date of Inspection: 28th Decemeber 2005
Property Description: **2 Bed Split Level Attached Residence**
Address of Property: **Mullens St Rozelle**
Client Name: Mr AB C/- Hyde Park SA 5061
Building Consultant: Dominic. J. Ogburn AMAIB
e-mail: info@accesspropertyservices.com.au
Master Building Consultant
Office (02) 9798 5000 Fax (02) 9225 9656 Mobile 0418 865-663

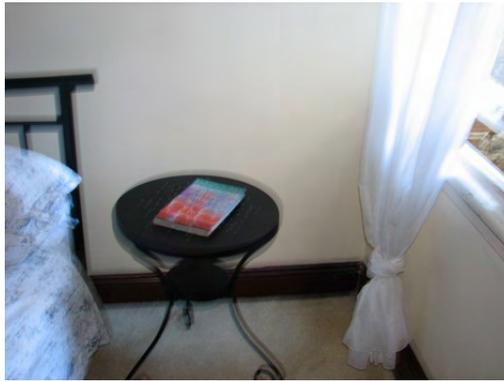
Photo No 1

Bed 2; Refer Photo No1 of moderate to heavy damp (and paint flake) within the *lower SE wall*, predominantly in last 1.5m of wall adjacent to external wall, which I consider has not had prior D.P.C replacement

Rising Damp; I **recommend** that installation of new chemical damp proof course to all noted lower damp walls, which will involve the physical removal of timber skirtings and all salt effected plaster and its reinstatement with a salt retardant treated type.

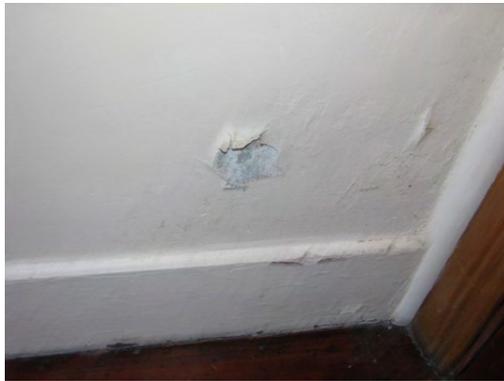
Photo No 2

Lounge/1st Flr Exit Door Lobby; moderate to high damp apparent in the approx 1m long section of *Lounge SW wall (Refer Photo No2)* which I consider has not had prior D.P.C replacement.

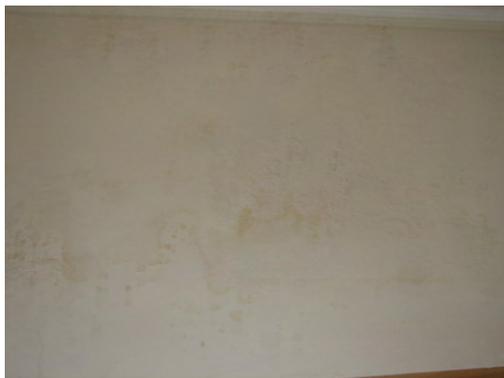
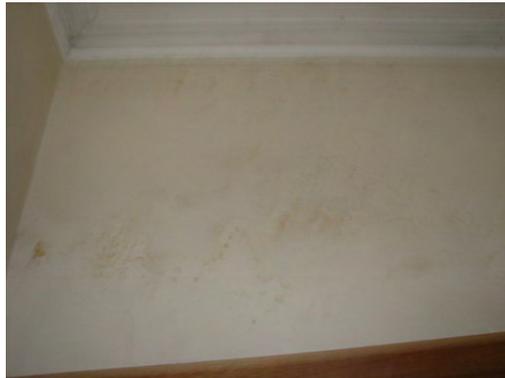
SE 1st Flr Exit Door Lobby; Refer Photos No3 & 4 showing extensive falling damp staining within the wall plaster and some sections of ceiling together with efflorescence. High to very high moisture content was recorded across the width of this wall but did not appear to extend into 1st Flt guest W.C external wall.

I was unable to adequately determine the exact cause of this moisture entry, as all roofing and parapet cappings appear sound, as does the external protective paint film.

Falling Damp; SE 1st Flr Exit Door Lobby I **recommend** that further investigative work be undertaken by way of gaining access into the upper additions structure and thoroughly inspecting its roof and external walls/ window openings, for likely causes of moisture entry.

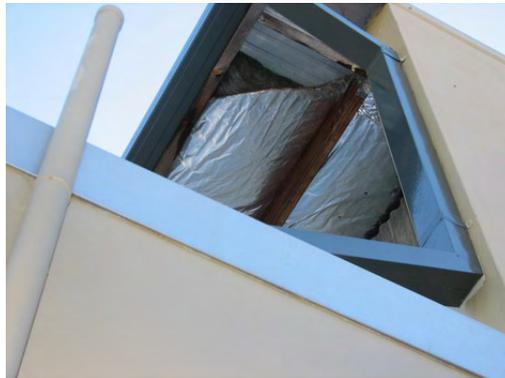
Photo No 5

I can only presume that moisture is somehow entering into the incomplete upper floor additions (*refer Photo No5*) and then transferring downward into this wall/ ceiling area.

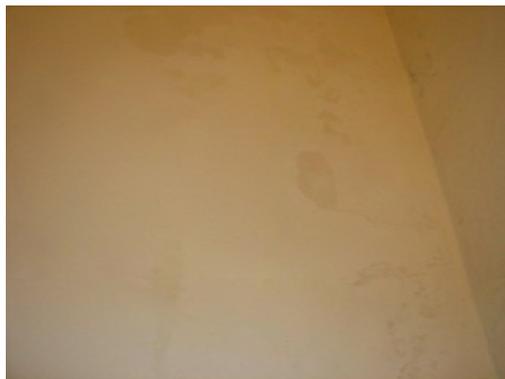
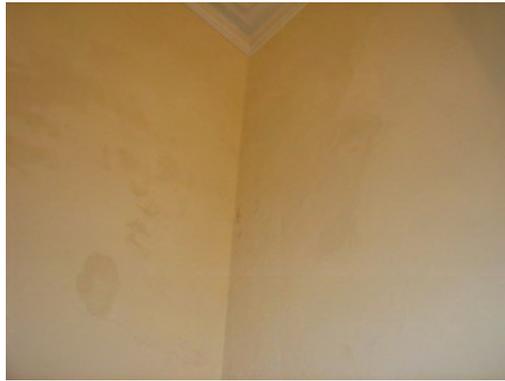
Bed 1; Refer Photo Nos 6 & 7 of the high to very damp and damp sating evident in the forward NE wall and forward SE wall (forward of fireplace).

I consider the cause of the current damp to be completely separate and independent of the prior noted cause of damp in this wall (namely falling damp) which was rectified by BRM as part of prior remedial works.

Bed1; I recommend that a new down pipe be installed to front elevation and preferrably connected to a new sealed storm water line (min 100mm diameter PVC) carried out to street kerb.

Allow walls to dry out, scrape off and replace all salt effected plaster and replace with a salt retardant treated type and reinstate paint finishes upon completion.

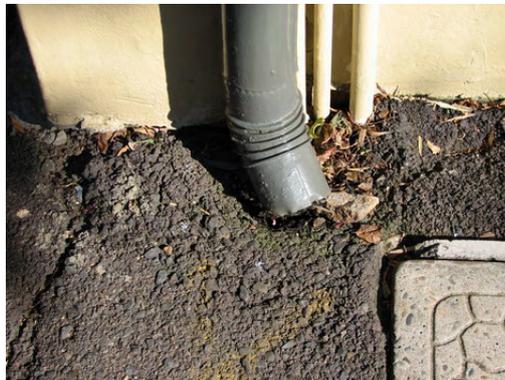
Photo No 8

Refer Photo No8 of a **completely blocked front down pipe and storm water line** beneath, which picks up the upper and lower roofs (*Refer Photo No8A*) and has been overflowing (at gutter level) leading to saturation of the waterproof painted SE external division wall (*Refer Photos No9*) and then moisture migration back to the internal damp walls as noted.

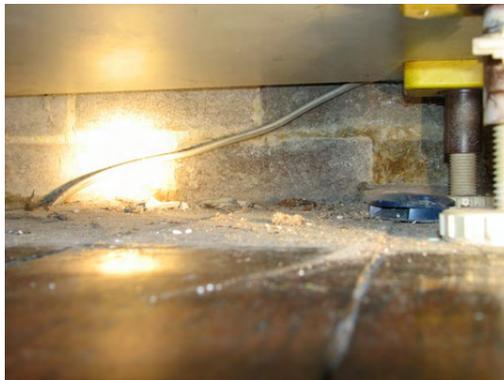
Photo No 10

Kitchen & Stairwell NW external Wall; removal of Kitchen cupboard skirting allowed moisture meter testing of the lower section of the NW brick wall (*Refer Photo No10*) which recorded high to very high damp. This damp continues across the same wall down into stairwell external wall (*Refer Photo No11*), which has lead to moisture migration into *timber stair* attached to this wall (*Refer Photo No11A*) and also into the *LGF NE wall (refer Photo No12 & 12A)*. Some section of the timber stair have a saturated content and if left unchecked will lead to soft rot deterioration and is a termite attractant. There is also evidence of moderate prior termite damage within a single stair riser (*Refer Photo No13*)

Kitchen & Stair NW External wall; Further investigation of this wall (from neighbours side is required) however in the first instance I believe that the wall will need to be rendered and then a water proof protective paint film applied to the entire wall face. Upon drying of internal wall finishes scrape off and replace all salt effected plaster and replace with a salt retardant treated type and reinstate paint finishes upon completion.
