Purpose of Report: Standard Pre Purchase Property Inspection
Date of Inspection: 24th October 2005
Property Description: 2 Bed F.S Single Storey Residence
Address of Property: Corunna Rd Stanmore
Invoice No.
Client Name: Ms AP C/- St Ives 2075
Building Consultant: Building Consultant Dominic. J. Ogburn AMAIB Lic No BC 359
e-mail: info@accesspropertyservices.com.ua
Office (02) 9798 5000 Fax (02) 9225 9656 Mobile 0418 865-663

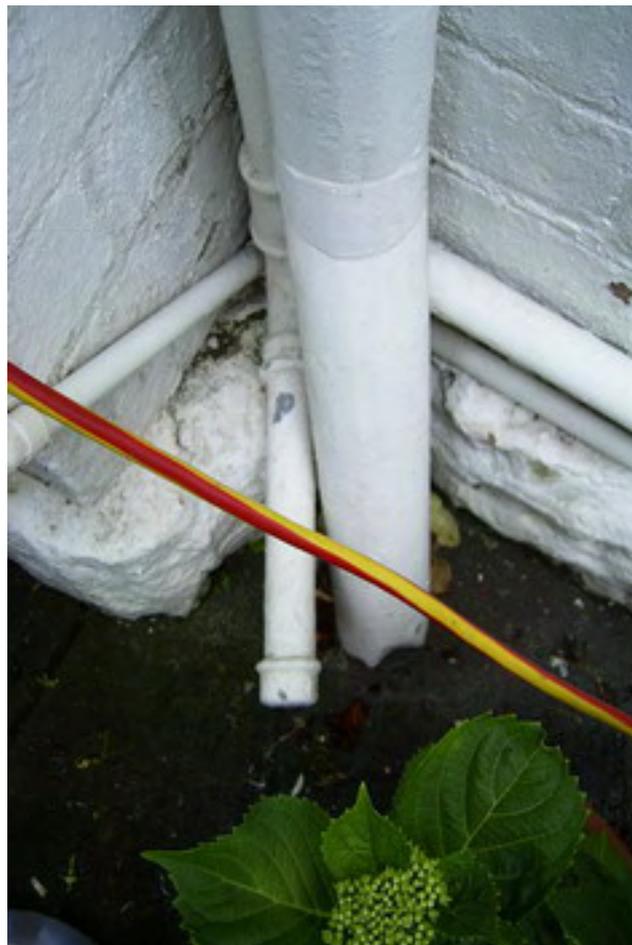
Photo No2

Noted Defects; *Refer photos No2, 3 and 4* showing the unconnected down pipes of the subject property together with the SW neighbours main roof down pipe, which discharges onto the side paving and which appears to have falls back towards the subject property.

We **strongly recommend** that all of the above noted down pipes be connected to a sealed storm water service carried out to the street.
