Purpose of Report: Pre Purchase Building Property Inspection
Date of Inspection: 17.5.2006
Property Description: 5 Bed Two Storey F.S Residence
Address of Property: Bellevue Hill
Client Name: Mr DW
Building Consultant: Building Consultant Dominic. J. Ogburn AMAIB Lic No BC 359
e-mail: info@accesspropertyservices.com.au
Office (02) 9798 5000 Fax (02) 9225 9656 Mobile 0418 865-663

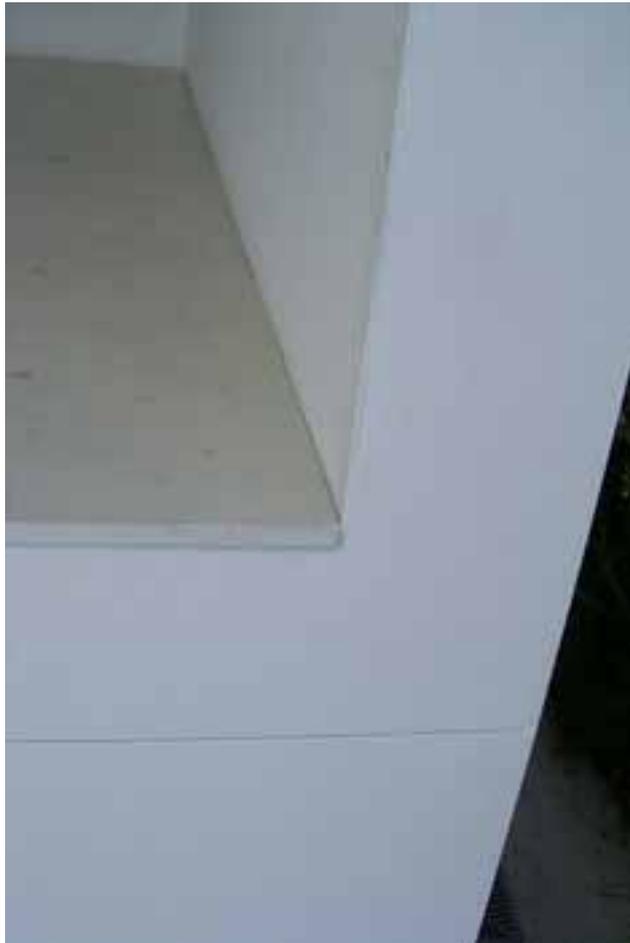
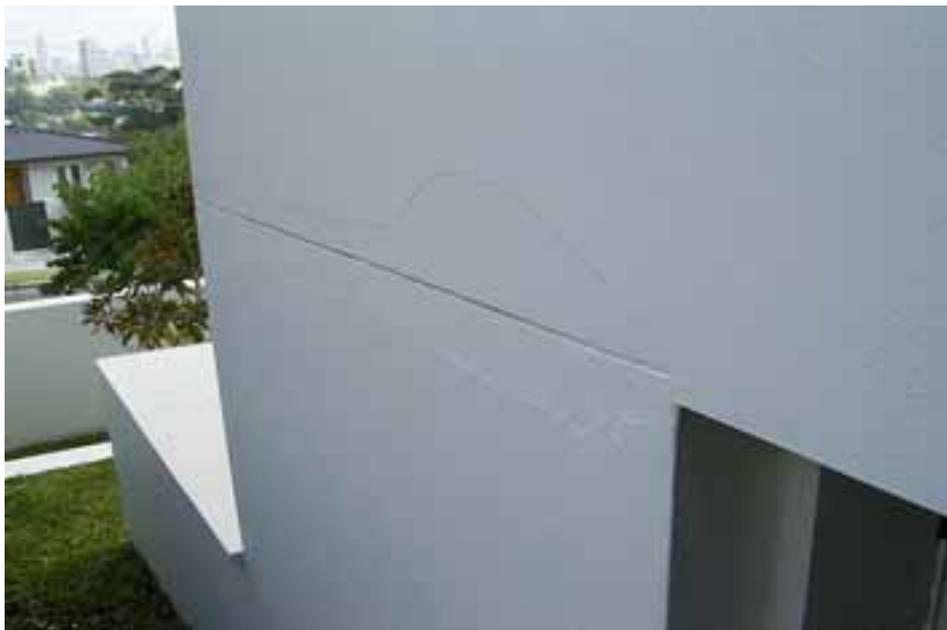
External (to house) Damp; evidence of prior patch painted high damp noted in the southern brick balustrade wall of *entry veranda*, as marked up on house plan – *Refer Photos 1 and 2*.

In my professional opinion the noted damp is most likely been caused by a failure at the wall/ floor junction of the waterproof membrane and requires rectification, which again I **recommend** be taken up with the project builders Pimas Gale for the investigation and rectification.

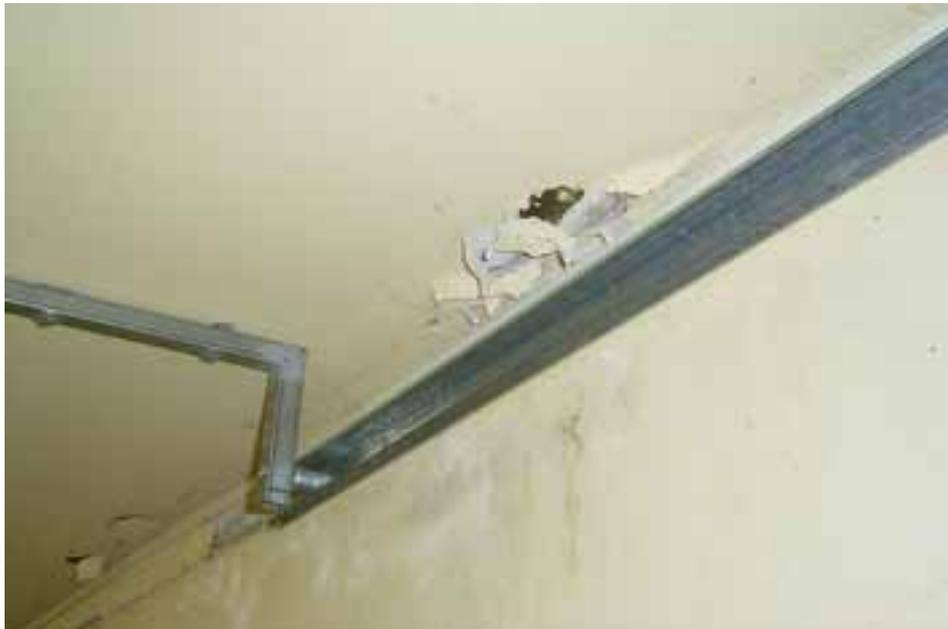
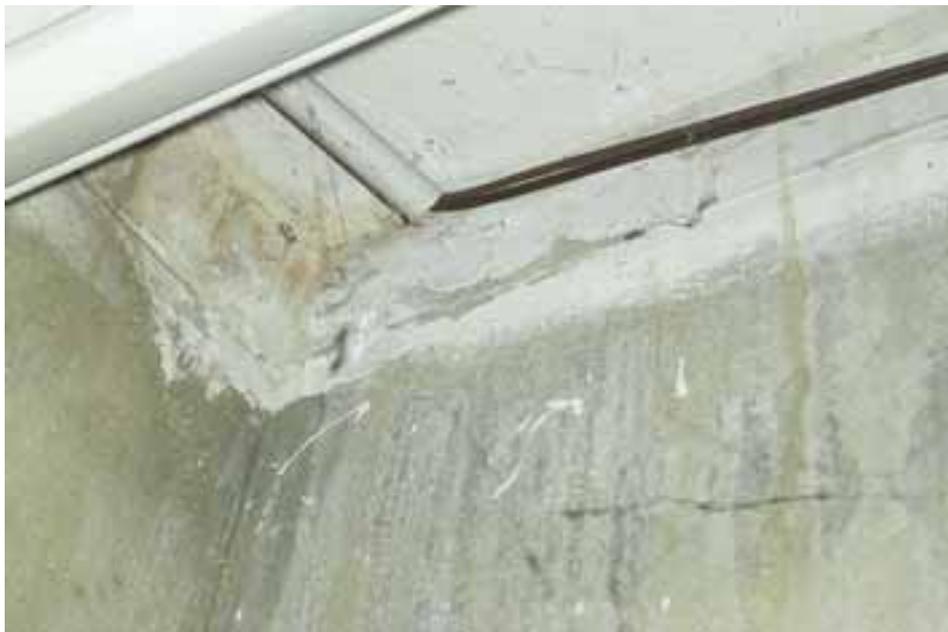
Significant evidence of falling damp noted that the upper **NE and southern garage walls** and slab soffit (*Refer Photos No 3 & 4*) together with aggressive efflorescence and high damp in the *external north garage wall* along with cracking in the external protective render and paint film (*Refer Photo No 5*).

In my professional opinion the noted Garage damp is most likely been caused by a failure of the waterproof membrane of the roof above particularly at the slab wall/ junctions.

I **recommend** that this damp issue be taken up with the project builders Pimas Gale for dye flood test investigation and rectification.

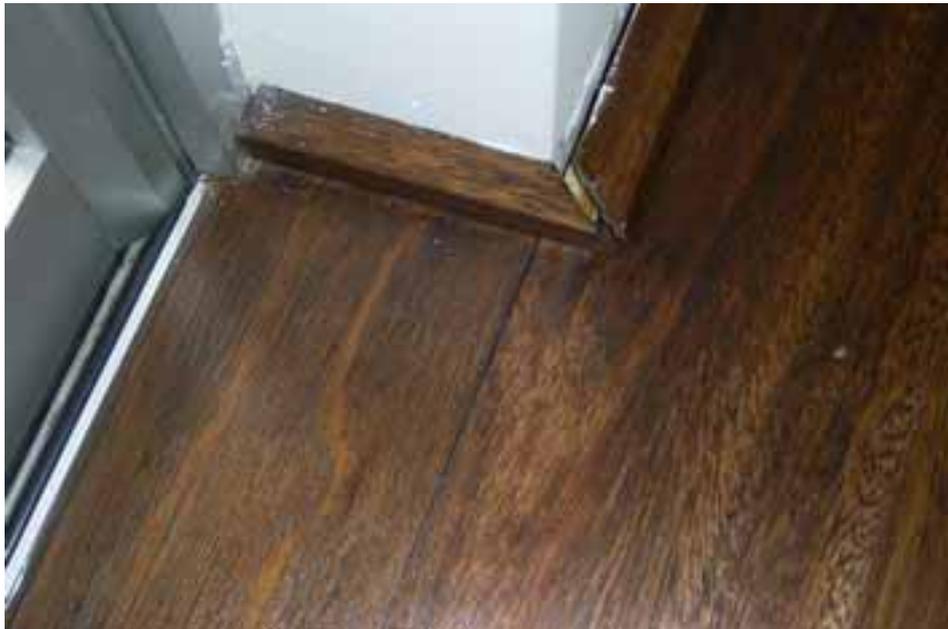
Photo No6

Noted Defects; Refer Photo No 6 showing how a section of skirting on the northern Dining Rm wall has dislodged, which I suspect is due to inadequate expansion provision for the flooring beneath. Refer below comments.

Noted Defects; Photo No 6 shows that a small *expansion joint provision* has been provided between the battened timber floor (which has minor evidence of cupping) and northern enclosing brick wall. In my professional opinion it is likely that inadequate expansion provision has been made and that this would have been contributory to the dislodgement of above noted skirting.

I **recommend** that this issue be taken up with the project builder for their detailed investigation and rectification.

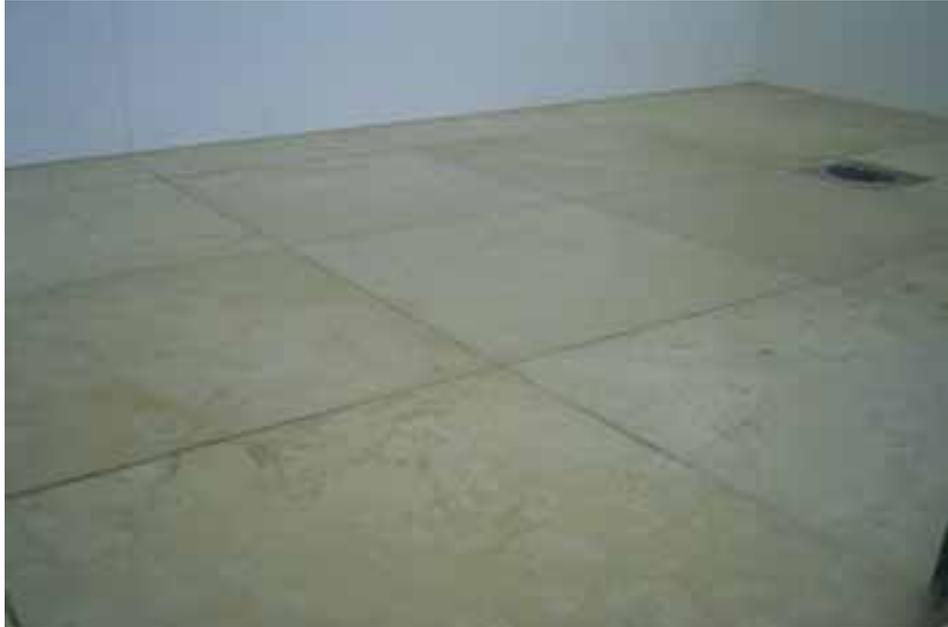
Photo No7

Noted Defects; at the time of my inspection *significant quantities of water or ponding* on the unenclosed shower recess floor – *Refer Photo No7.*

I undertook a basic water test and determined that further ponding occurred.

In my professional opinion the as built unenclosed shower recess is not in accordance with the minimum requirements of A.S. 3740 (at the time of construction) and that failure to rectify same could lead to loss of amenity through permanent dampness and mould promotion.

I **recommend** that this issue be taken up with the project builder for their investigation and rectification, which is likely to require the entire removal and reinstatement of the shower recess floor with special attention given to diagonally cutting tiles around shower waste.

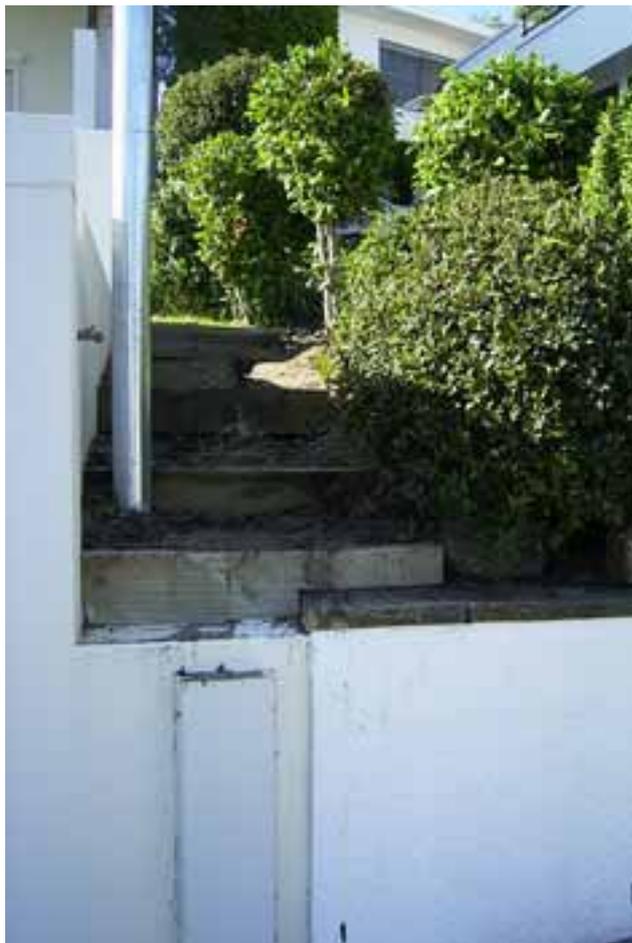
Photo No12

Refer Photo No 12 showing significant soil erosion over the front retaining wall, with resultant sand debris spilling onto footpath at entry for subject property. It would appear that this erosion is occurring due to overland surface water flow from the southern neighboring property, the exact cause of which I was unable to determine but which is possibly associated non sealed stormwater outlet. I suggest that this issue be in the first instance taken up with the neighbor and that they be asked to rectify. Should they fail o do so I suggest that the issue be elevated to Council level.
