**Partial External Facade
Building Survey Report**

Levels G.F – Lower Penthouse (& two private lots)

ABC Apartments
Strata Plan No 70XXX

Darlinghurst

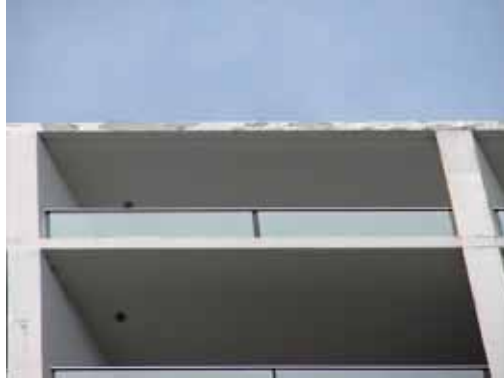
Photo No1

At the *external face of balcony concrete pergola beam* (of lower floor unit), which I had previously observed in my March 2004 report – *Refer Photo No1* (this report).

In my professional opinion, moisture entry has been occurring in this location for near on two years and such paint film delamination, in such a location, is most likely to have occurred due to the ingress of water behind the protective paint film (supposed to resist all moisture entry) possibly through the horizontal top beam edge, which may not have adequate falls and allows ponding to occur.

I **recommend** that consideration be given to the installation of *drip grooves* on all exposed building elements such as balcony pergola beams and that the tops of these beams should resist ponding of water by having adequate falls to the external edges.

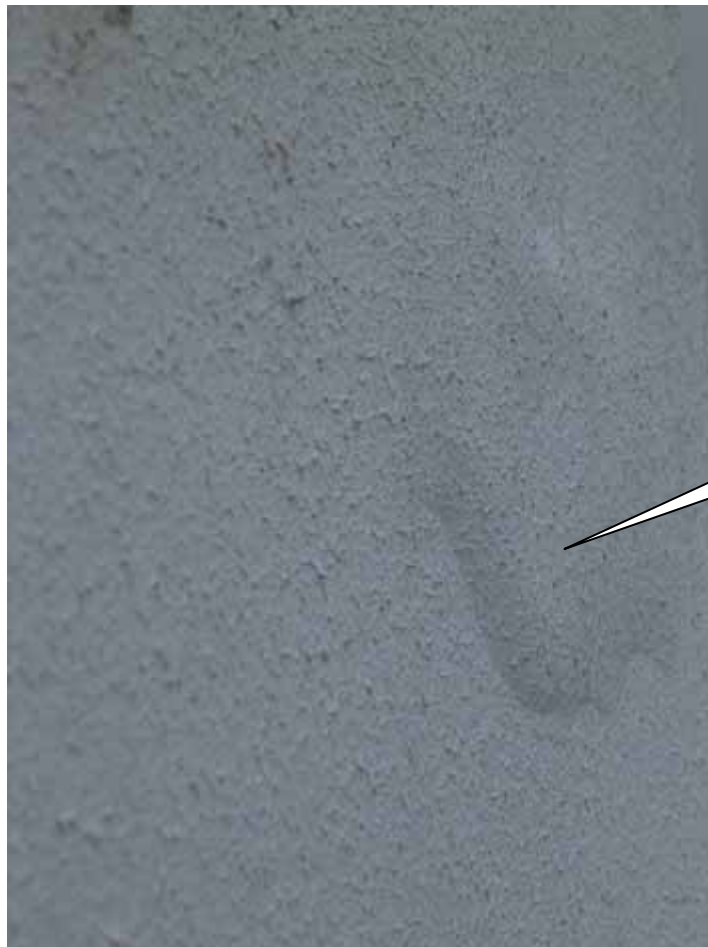
Photo No2

Severe moisture related *paint bubbling\ballooning of paint film* on some external faces of vertical columns – *Refer example Photo No2*, located beneath the pergola beam.

In my professional opinion such paint film bubbling is most likely to have occurred due to the ingress of water from above via falling damp, and having been trapped behind the paint film would lead to either very high or saturated moisture content of the substrate, currently making it unsuitable for paint re-application.

Water filled paint

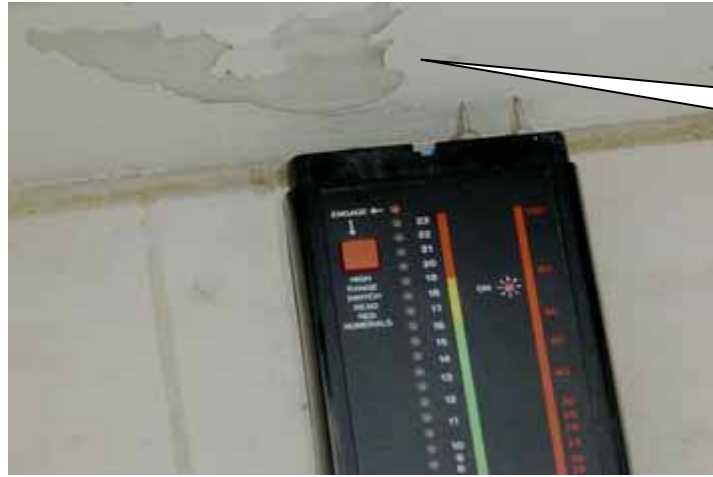
Photo No3

Spot moisture meter testing revealed *saturated moisture content* in the lower sections of concrete balcony columns and the balcony hob upstand, in various locations – *Refer example Photos No3 & 4*.

In my professional opinion such high moisture gain is most likely to have occurred due to the ingress of water from above via falling damp and/or possibly due to differential movement cracking and having been trapped behind the paint film, this would lead to the saturated moisture content of the substrate, currently making it unsuitable for paint reapplication.

Saturated lower balcony wall

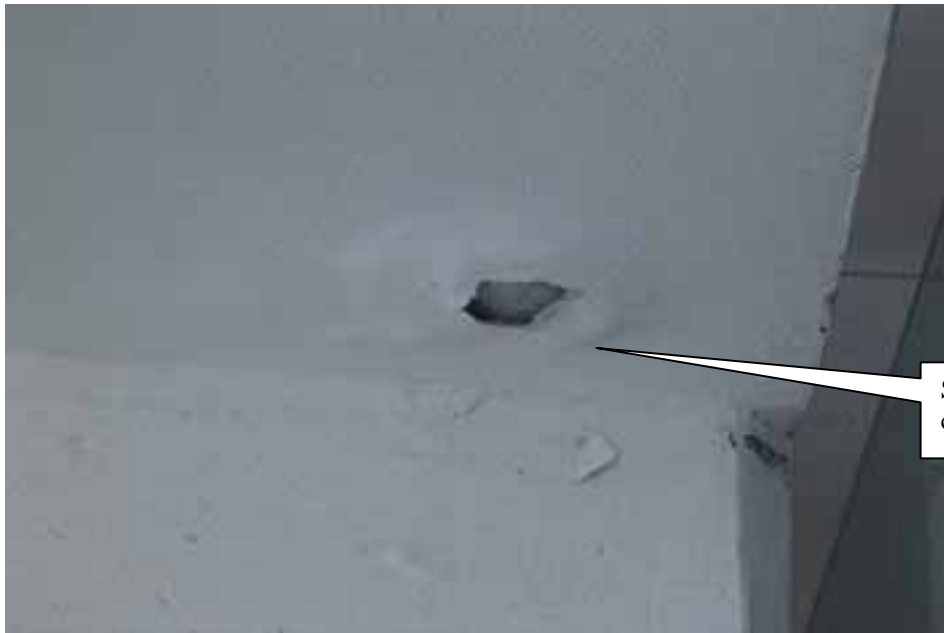
Photo No4

Saturated lower concrete column

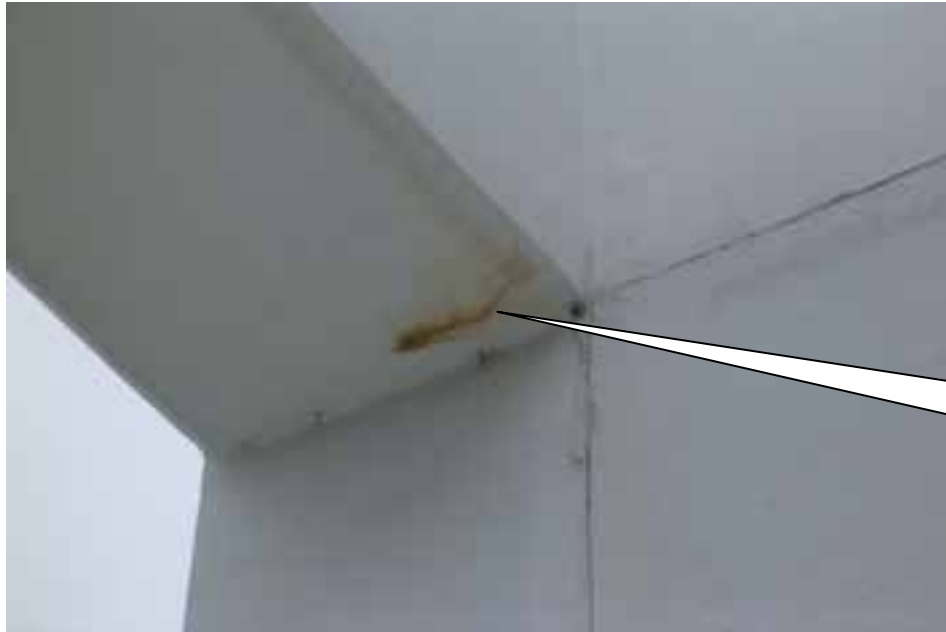
Photo No5

Moisture related *minor concrete spalling* at the pergola beam soffit – *Refer example Photo No5*.

In my professional opinion such minor spalling is most likely to have occurred due to the ingress of water from above and the presence of either reinforcement tie wire or a bar chair support legs near the soffit face of concrete pergola beam and also possibly due to the lack drip grooves on any of the pergola beams – *Refer example Photo No5*.

Moisture related
rust spalling &
lack of drip
grooves

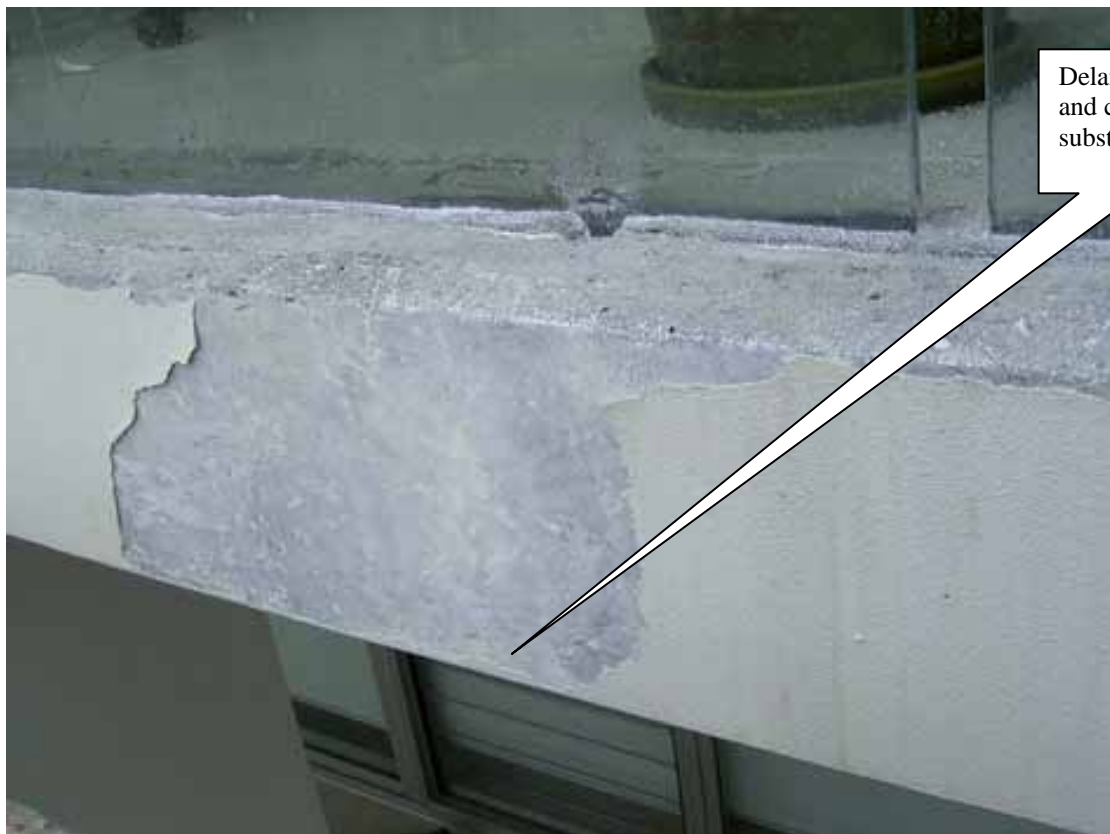
Photo No6

Delaminated paint
and chalky
substrate

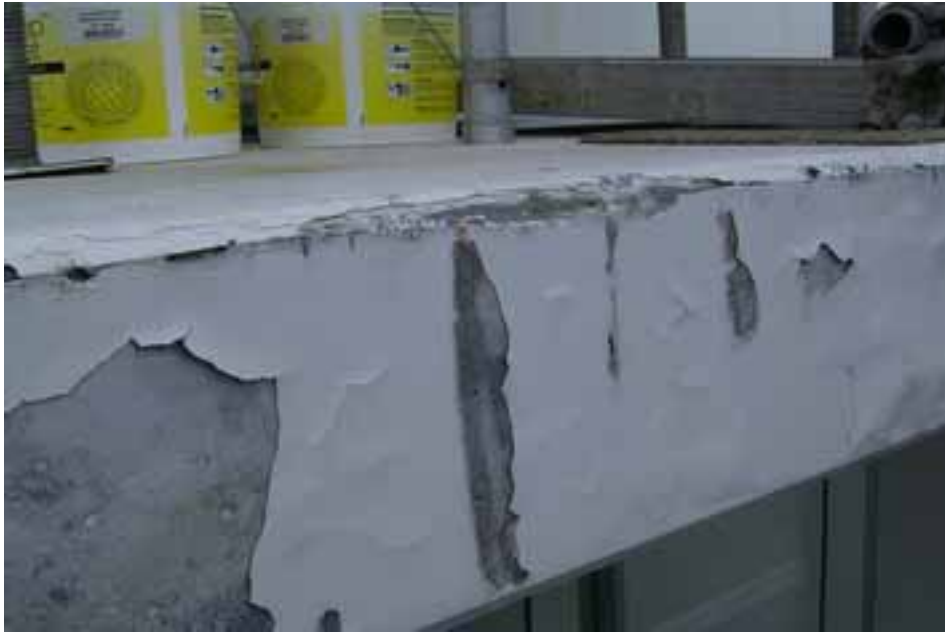
Photo No8

At the external face of balcony edge, (as observed from swinging stage)– Refer Photo No8. In my professional opinion such paint film delamination in this location is most likely to have occurred due to the ingress of water behind the protective paint film (supposed to resist all moisture entry) possibly promoted by ponding and inadequate surface drainage.

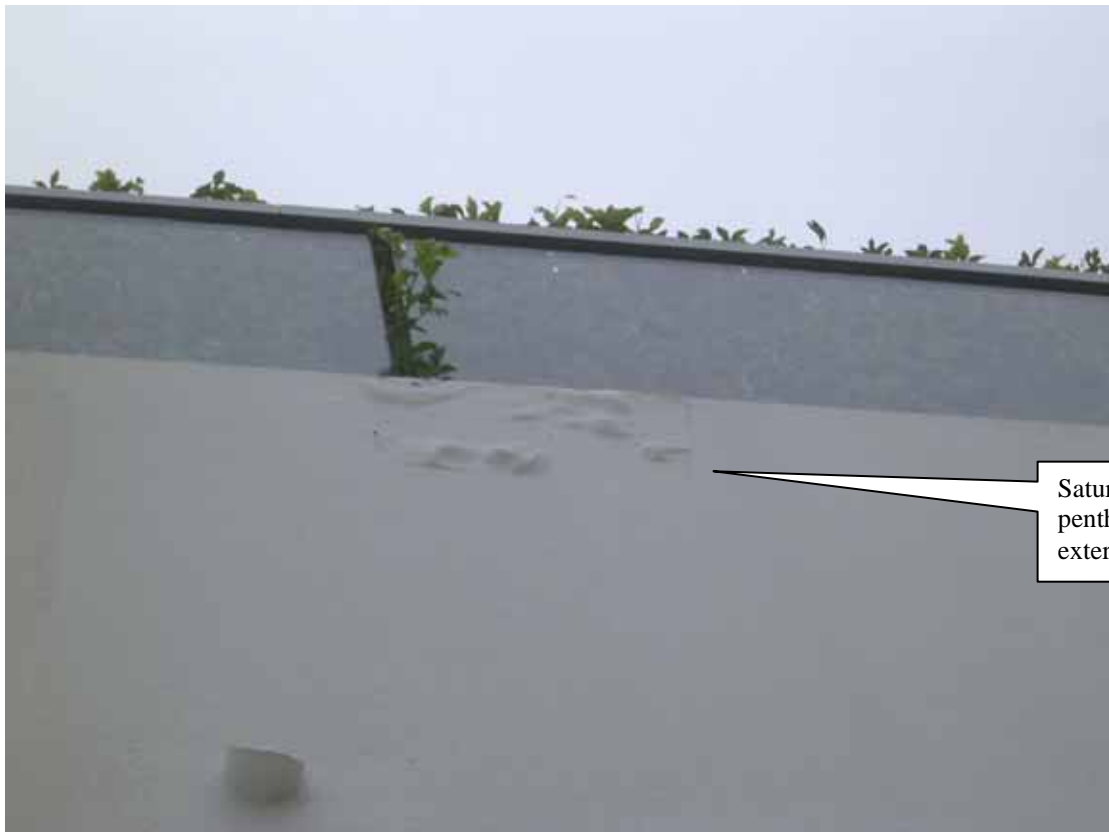
Photo No10

In my professional opinion such paint film delamination in this location is likely to be caused either due to a failure in the planter box waterproof membrane behind or in the protective paint film, possibly due to glass balustrade installation detail– Refer Photo example No10 and more detailed explanations of same at Section 1.92 of this report.

Saturated upper penthouse level external planter box

I **recommend** that the Penthouse upper floor eastern planter box waterproof membrane be checked for integrity.

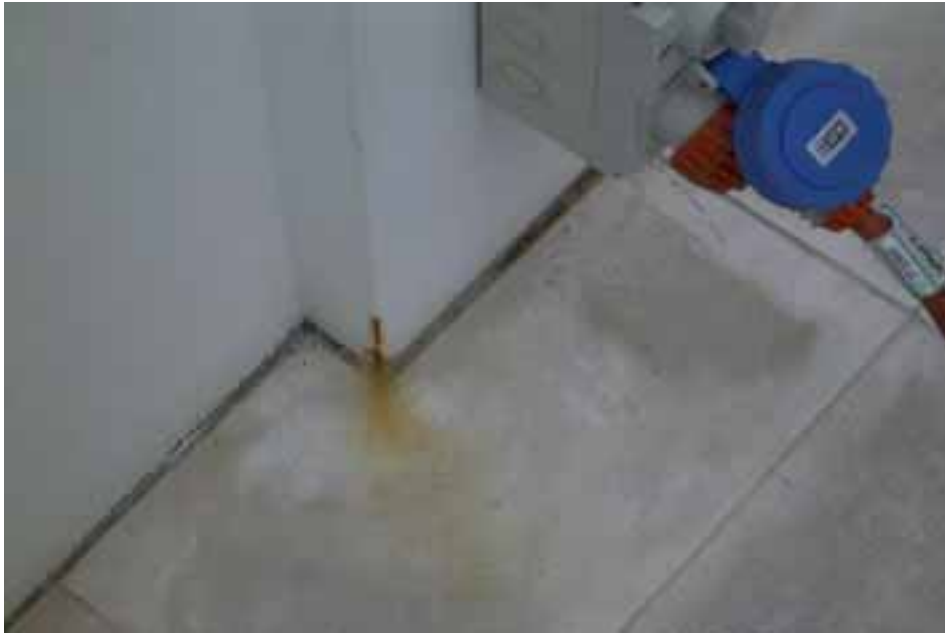
Photo No14

Very significant *rust staining and evidence of moisture seepage (at base)* of the seemingly *steel stud, fibre cement clad* service pipe enclosure at the southern end of this balcony – *Refer Photo No13 & 14* and which is fixed to a masonry wall

In my professional opinion such significant rusting and lower wall seepage, in this location, is likely to be caused either due to a failure in the protective paint film above, and/ or due to an inadequate waterproof detail (to accommodate differential movement) between the steel stud wall and masonry wall. The resultant rusting has occurred due to the presence of metal external setting edges been used when setting the fibre cement sheets.

If the balcony waterproof membrane has not been carried through beneath this stud framed enclosure, then the noted seepage would be gaining entry into the balcony slab.

I **recommend** that the front F.C panel of stud framed service enclosure be removed and that the presence of a waterproof membrane, on the balcony slab directly beneath, is verified.

I **recommend** that the junction of the steel stud enclosure and masonry wall incorporate an adequate waterproof expansion joint (including breaker bond) which accommodates differential movement and that all metal external angles and rusted screw fixings be removed and replaced with a rust resistant type (e.g. plastic external angles).

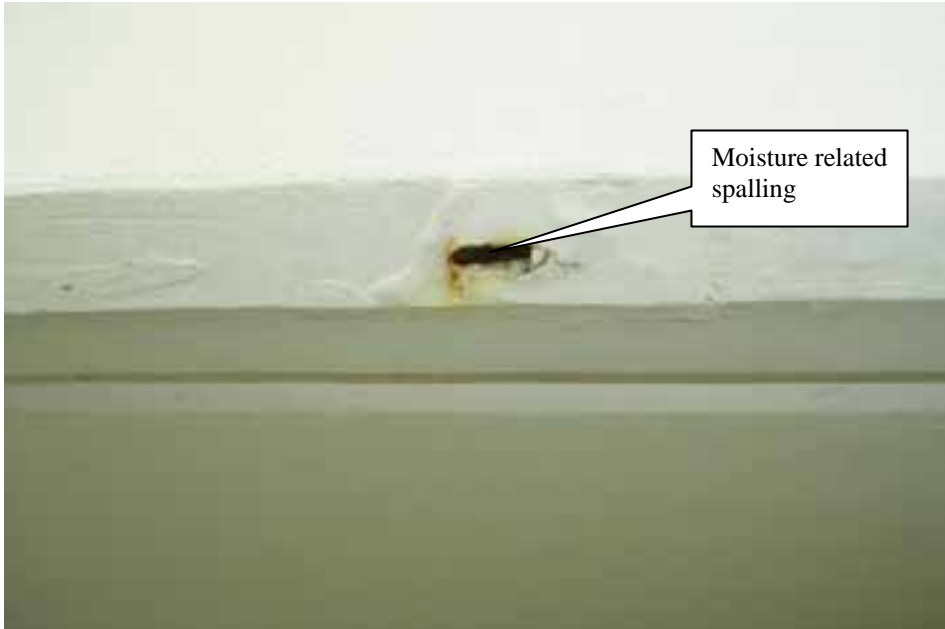
Photo No17

Moisture related *minor concrete spalling \ rust staining* on the balcony slab edge – (as seen from swinging stage) *Refer example Photo No17.*

In my professional opinion the most likely source of the above noted moisture entry would be due to a failed protective paint film on the balcony above however it is possible that moisture is entering the slab because the balcony waterproof membrane has not been carried through beneath the above noted stud wall.

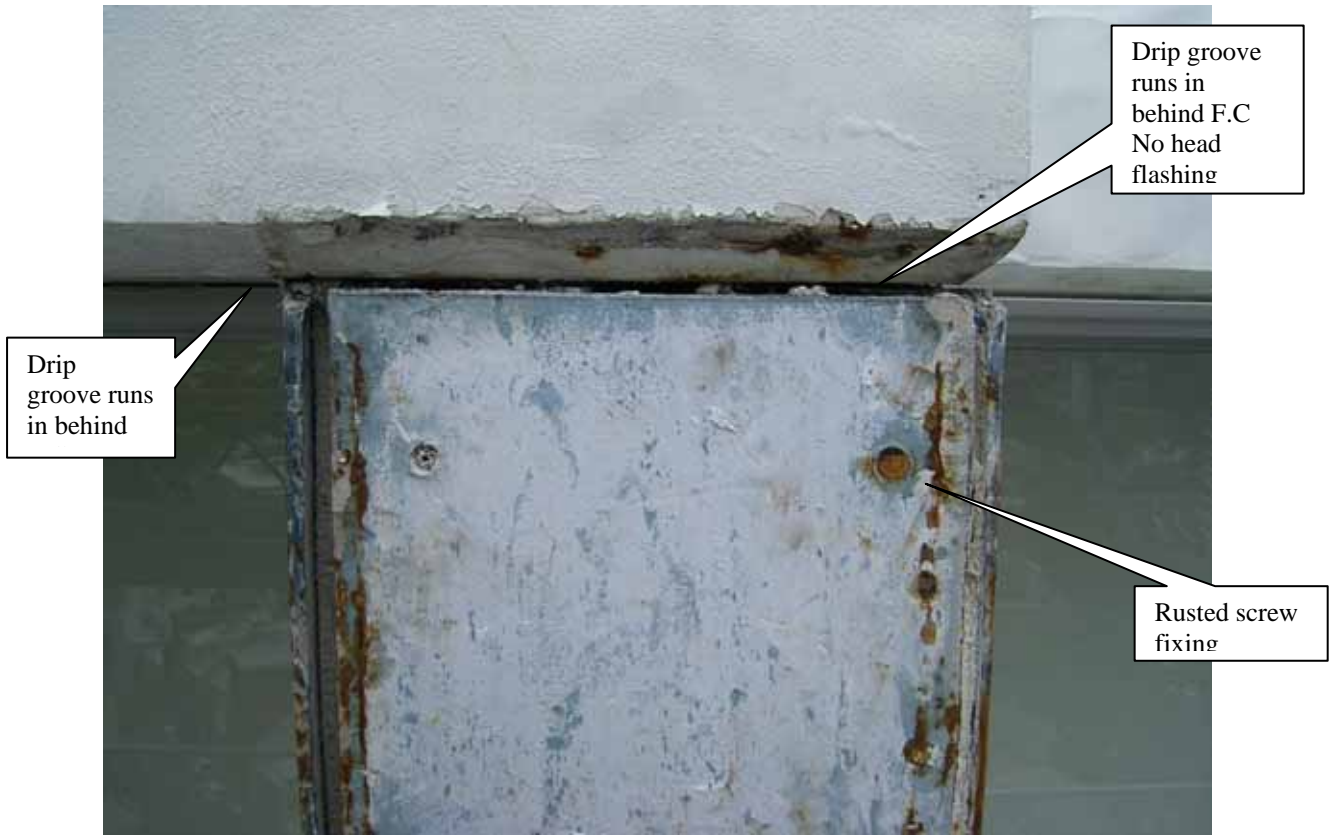
Photo No19

From my eastern balcony facade inspection (from swinging stage) I determined that the F.C clad columns /walls have been constructed from *lightweight steel studs* and that non- rust resistant *screw fixings* have been used to fix the F.C. cladding.

There was evidence of significant rusting to both of same from the limited inspection area available - *Refer example Photo No19.*

In my professional opinion *significant rusting* is likely to be present in many of these concealed structural elements (steel studs and screw fixings) and failure to adequately rectify same is likely to lead to future rust staining after the new exterior coating is applied.

I **recommend** all heavily rusted metal components including steel studs and screw fixings be either replaced and/or rust paint treated, depending on severity and that all metal external setting angles be replaced with a rust resistant type (e.g. plastic external angles). James Hardie technical manager Mr. Jesper Jensen (blue board manufacturers) recommends use of stainless steel screw fixings and plastic setting external edges for their blue board F.C.

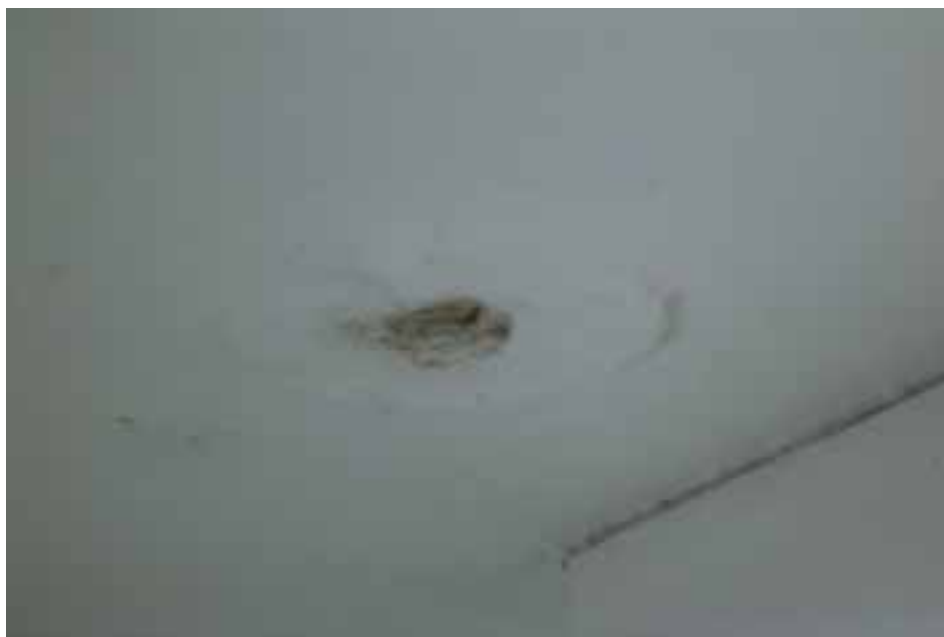
Photo No20

Severe evidence of *moisture related paint film bubbling, staining delamination and calcification* on the sub penthouse balcony rearward slab *soffit*, at three locations along its length, in near proximity to F.C clad columns *Refer Photos No20, 21 & 22.*

In my professional opinion this moisture related paint film damage and calcification has occurred due to the presence of *very high moisture content within the balcony slab* and which is entrapped by the exterior coating.

The noted calcification (lime leaching) is heavy and in my opinion has occurred because of long-term saturation of the slab.

I **recommend** that all the moisture damaged exterior coating on the sub Penthouse balcony soffit/s be thoroughly stripped back and the slab allowed to dry.

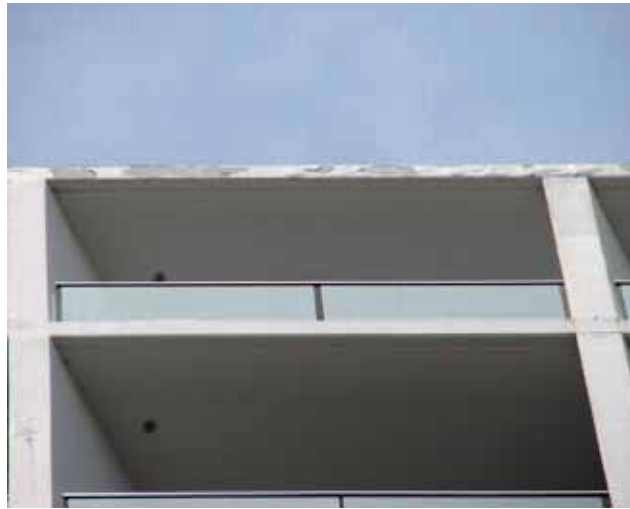
Photo No1

Refer Photo No 23 & 24 showing evidence of very significant **moisture related paint film bubbling and delamination particularly at junction of balcony slabs and dividing end walls**
Refer also prior noted comments relating to Photo No 1 (of this upper elevation)

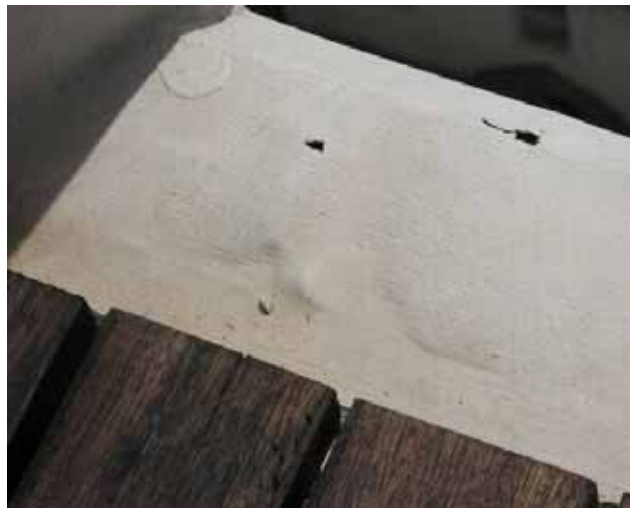
Photo No25

Refer Photos No25, 26,27 & 28 (of unit **1501**) west facing balcony showing significant **moisture related paint film bubbling and delamination** to the external/ internal balcony painted hob slab edge. *Refer Photos No29 & 30* (of unit **1501**) and moisture related rust staining to F.C clad columns.

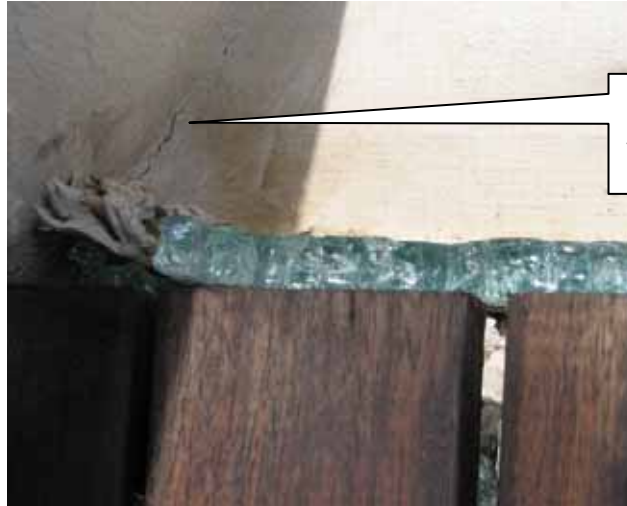
Photo No27

Photo No 27 shows hairline cracking in the protective paint film at junction of slab and lower wall, which would permit moisture entry.

In my professional opinion if this joint had been filled with polyurethane sealant and no breaker bond was installed between the two different materials, then differential movement cracking can occur because the two materials do not like each other.

Hairline crack @ sealant filled junction of balcony hob and F.C column

Moisture related exterior paint delamination

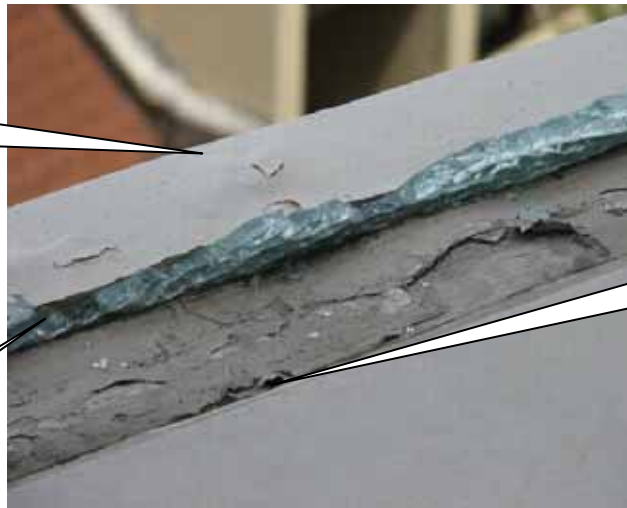
Photo No28

Moisture damaged acrylic coated internal hob (little falls)

Broken glass balustrade

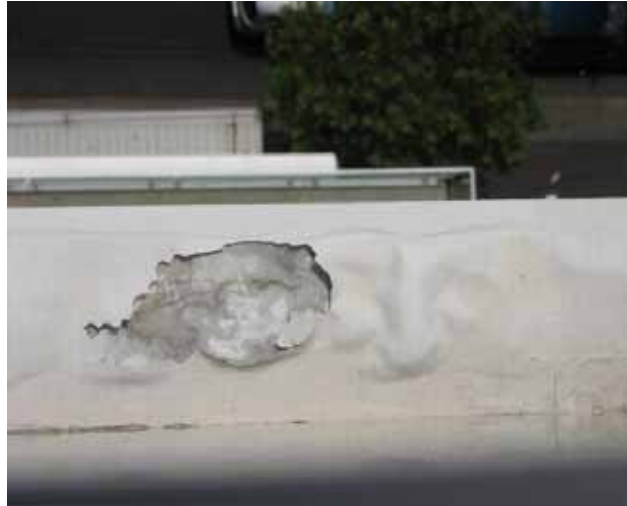
Refer Photo No31 (of unit **1105**) east facing balcony and showing significant **moisture related paint film bubbling and delamination** to the external/ internal balcony painted hob slab edge

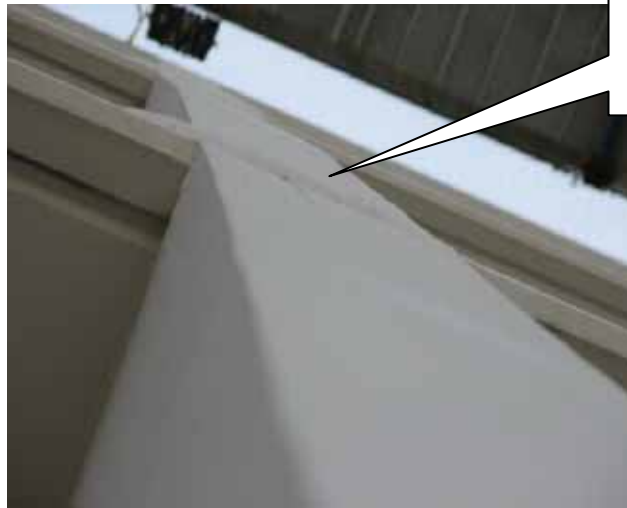
Photo No32

Refer Photos No32 & 33 (of unit **1105**) showing very **significant moisture related paint film bubbling** on the external face of solid North end wall (of the balcony over) and in the upper North wall (of subject unit) just beneath slab soffit and drip groove.

Severe water filled paint bubble @ junction of balcony slab and concrete wall

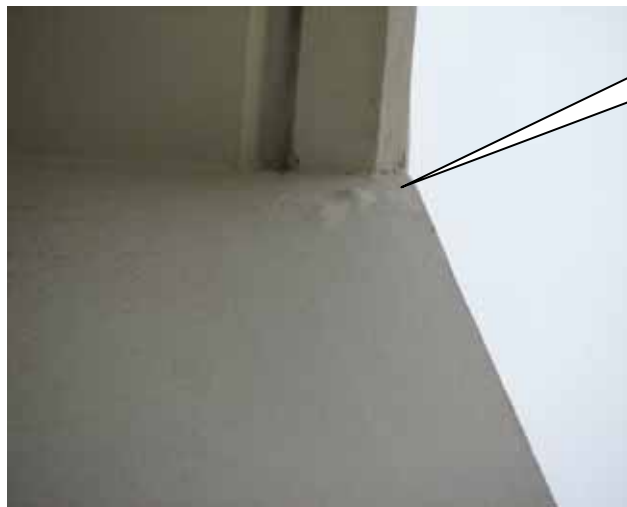
Photo No33

water filled paint bubble @ balcony slab soffit below balcony balustrade

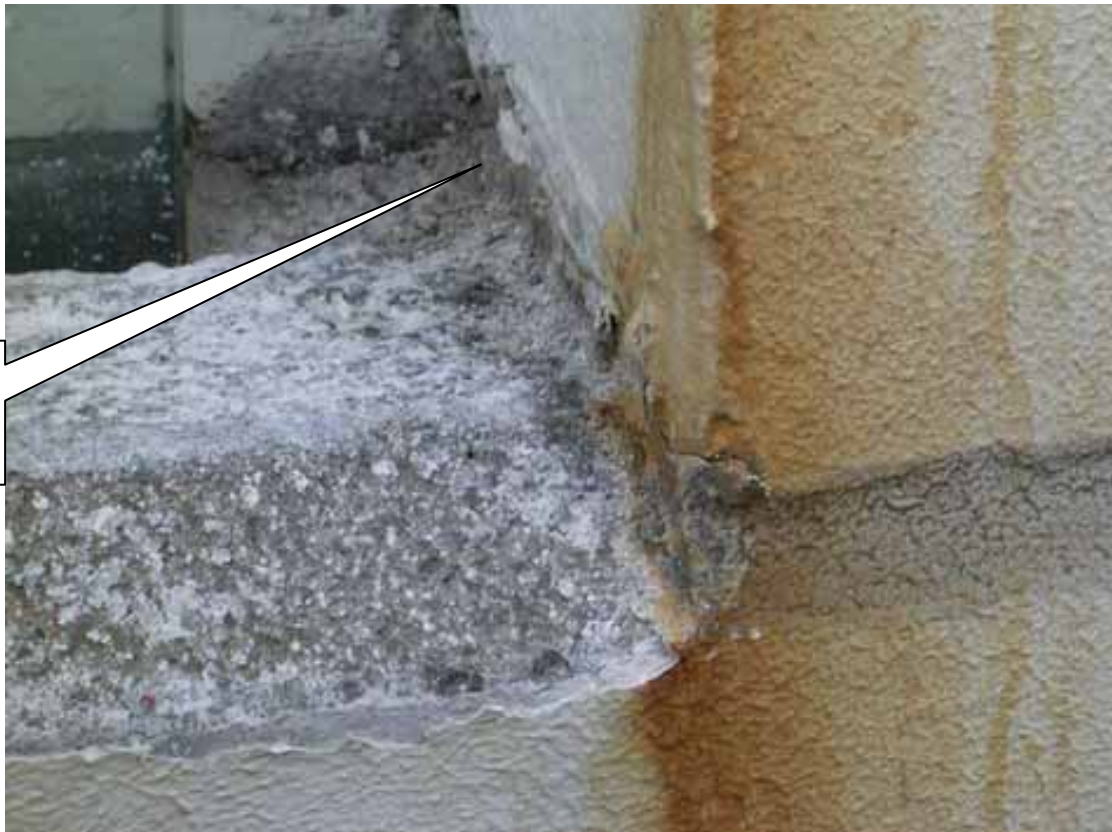
Photo No37

Numerous lower balustrade rebates were highly moist and the gypsum filler in some instances were saturated. *Refer example Photos No 37 and 38* showing junction of balustrade rebate and rusted F. C. clad column and/or concrete\masonry blade wall.

Base of F.C
column sealant
filled no
flashing

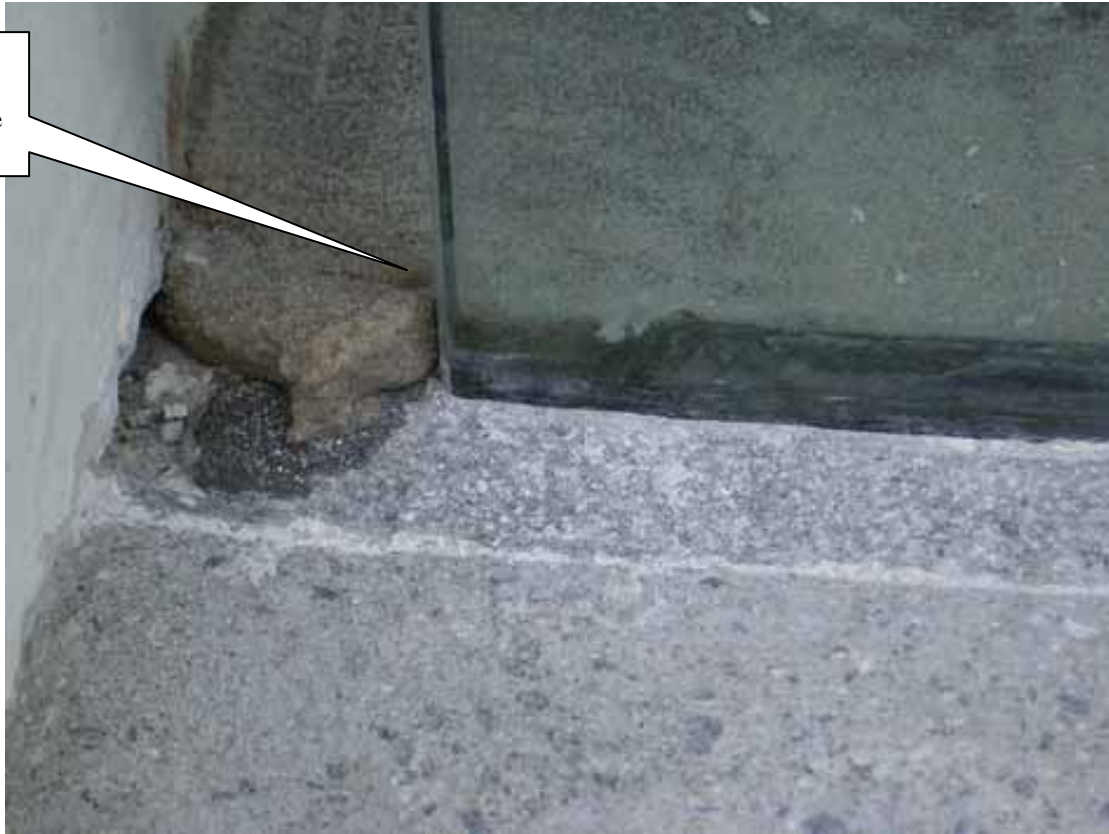
Photo No38a

New epoxy
filler hard up to
glass balustrade
and end wall

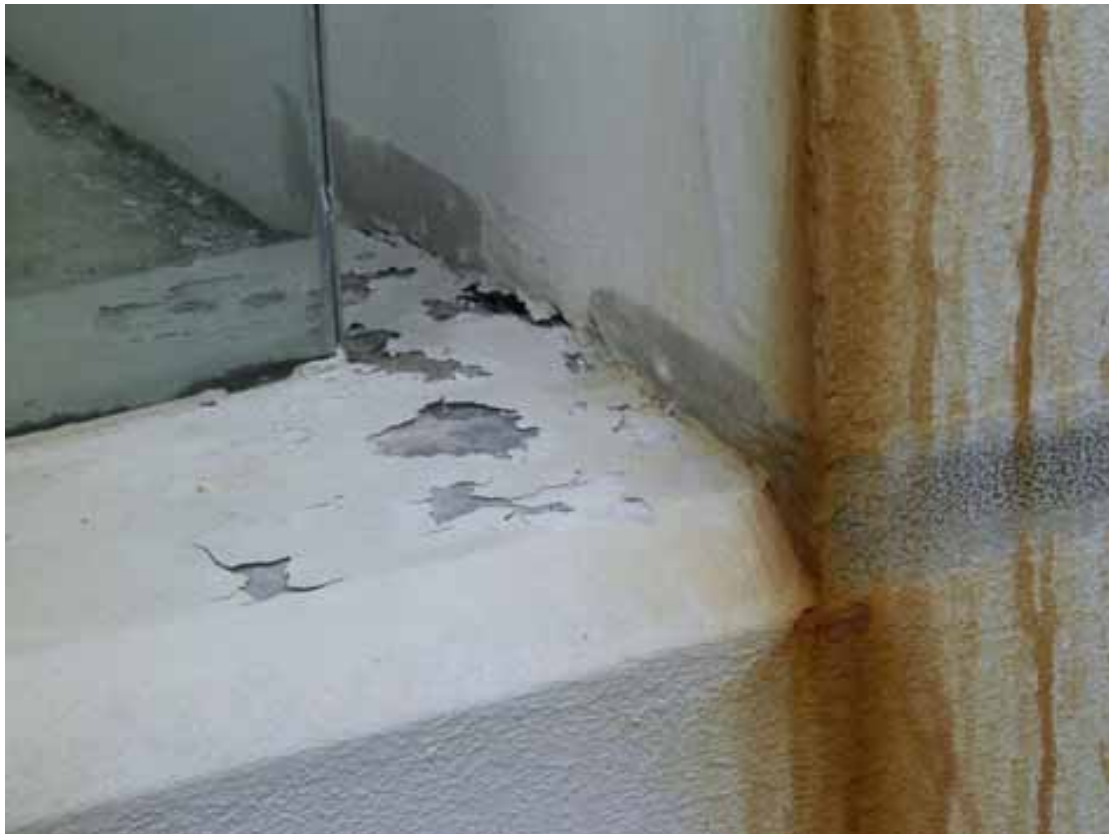
Photo No40

In most instances (internal and external hob edges) there was very significant evidence of moisture related paint film break *Refer example Photos No 39, 40, 41, 42 and 43* indicative of moisture related damage, at the balcony hob/edge and lower sections of end wall (abounding glass balustrades).

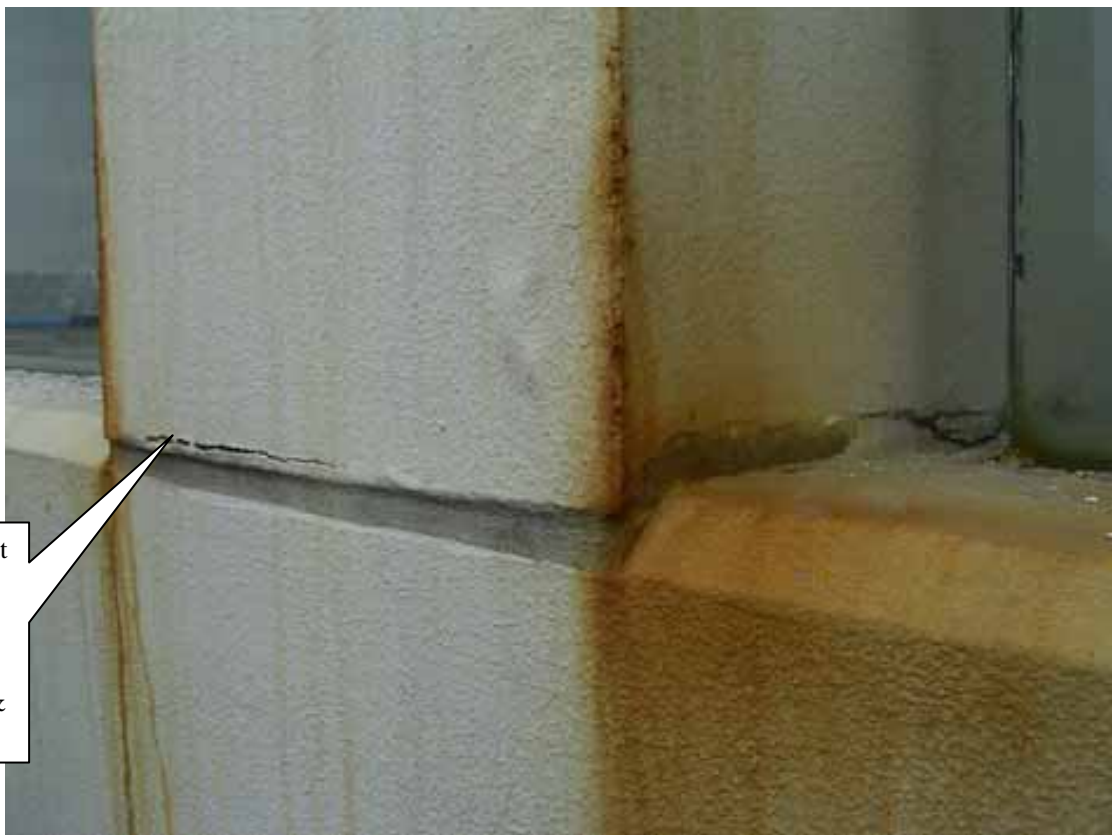
Photo No42

Cracking @ sealant filled joint of external F.C cladding (no breaker bond between sealant & external coating)

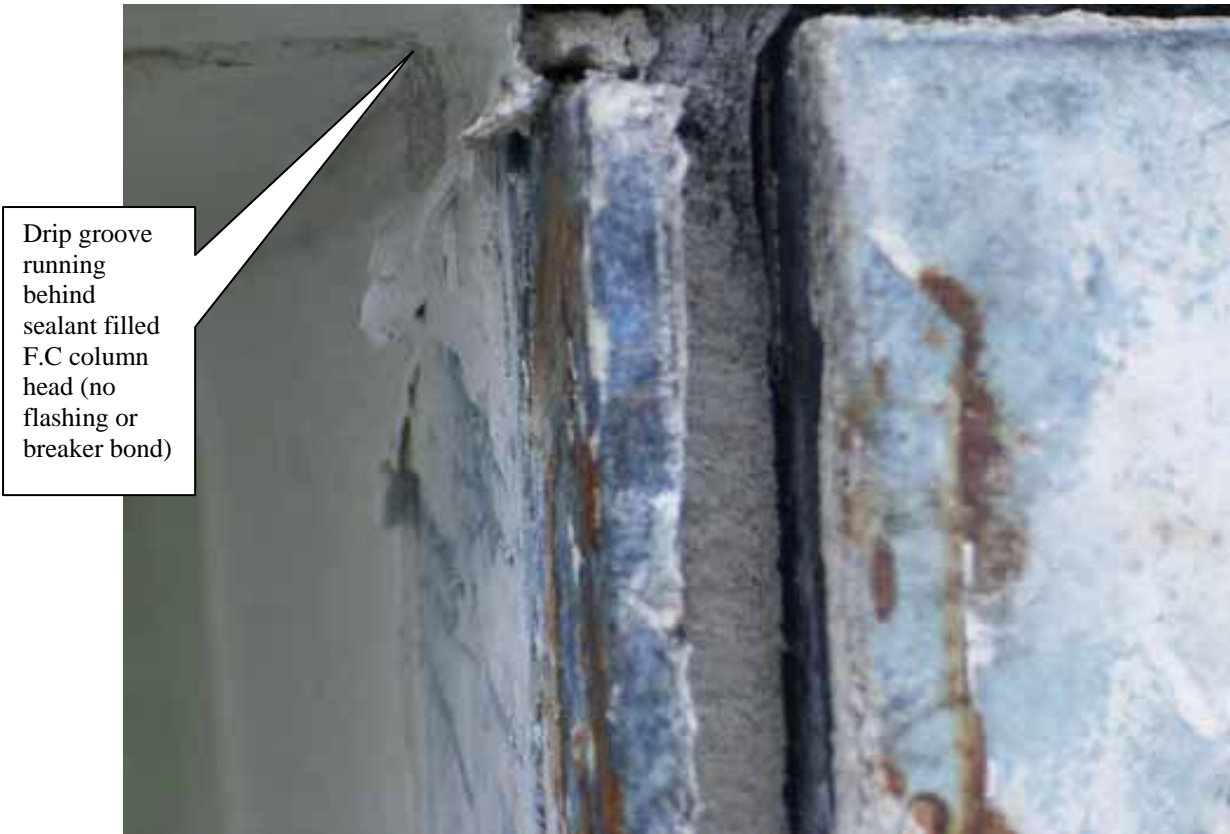
Photo No46

Drip groove running behind sealant filled F.C column head (no flashing or breaker bond)

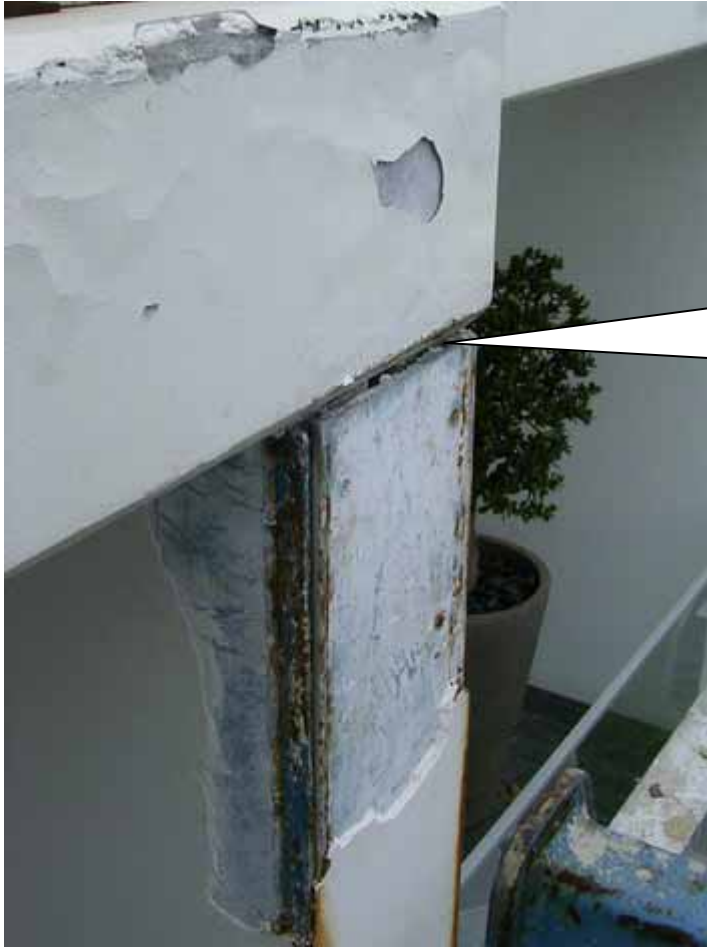
Photo No48

Evidence of rust seen in sawn tops of steel stud framing and fixing screws
