Partial Building Defects Survey Report

Basement & units 1,2,3,5,6 & 7 (bathrooms & balconies)

Rose Bay

The Owners Corporation
Strata Plan No 67XXX

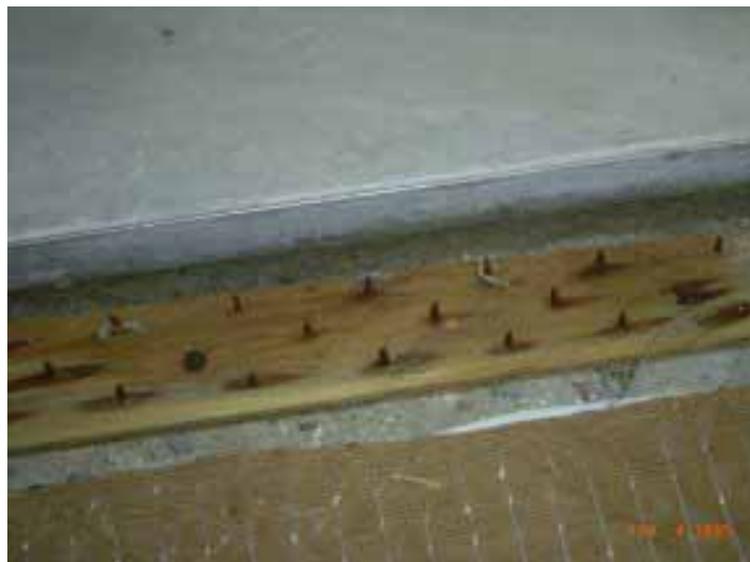
Damp; there was visual evidence of moisture related staining to the tile grout outside of the shower area and moisture meter testing of the tile bed (outside of the shower area) and at the bathroom entry, recorded high moisture readings. It was further apparent that some moisture had seeped down onto the carpet and smooth edge (@ bathroom entry) causing moisture related staining to the rear face of carpet and mild rusting of the nail fixings and lower metal door jamb *Refer example Photo No20A at pg 22.*

In my professional opinion the unacceptably high moisture content within the tile bed (outside of the shower area) and the apparent seepage that is occurring at bathroom entry would be due to moisture migration out side of the shower area, due to either the lack of and/or a defective 'water stop'.

Rectify inadequate falls (to prevent unacceptable pooling) and install 'water stop' that projects above the floor tile surface. Rectify damaged carpet and rust paint treat lower door jamb.
