Common Area Building Survey Report
Of
Levels Basement – Roof (parts of three private lots)

North Sydney

The Owners Corporation
Strata Plan No XYZ5X

Prepared By
Access Property Services Pty Ltd

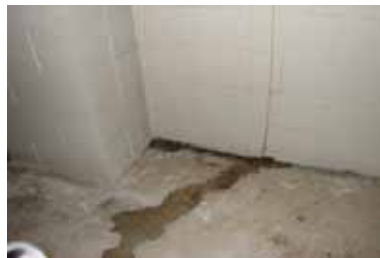
Photo No 14

Noted Defects; 100mm diameter pipe at western end of car space **No 207** is significantly **leaking Refer example Photos No14 & 14a.**

Recommendations; In my professional opinion said leak is most likely associated with a failure in the waterproof membrane directly around the stormwater pipe on the Level above and which requires rectification.

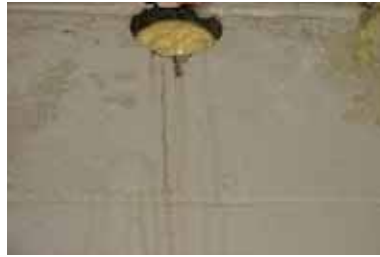
Photo No 15

Refer Photo No15 of **moisture related paint film delamination** in the lower northern **retaining wall** (at the end of car space No **105**) which was moisture meter tested and revealed **high damp.**

Recommendations In my professional opinion said damp is likely to be caused by a failure in the external waterproof membrane of the retaining wall and which requires rectification.

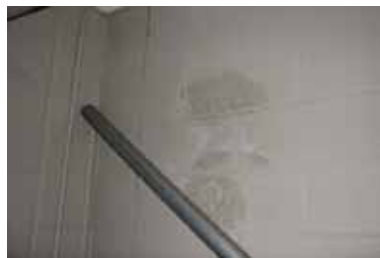
Photo No 16A

Refer Photo Nos16,16a, of **significant leaks** in and around two **pipe penetrations** in the **upper western basement retaining wall** (beneath Miller St frontage), which has lead to moisture related efflorescence and paint film bubbling – **Refer example Photo No17.**

There is evidence of prior failed patch remedial works to the pipe penetrations.

Moisture meter testing of the adjacent wall revealed high damp.

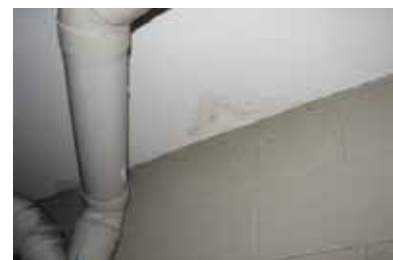
Photo No 18

The ceiling was moisture meter tested and the majority of area was **saturated** and has very significant moisture related damage – **Refer Photo No18 &18a.**

Recommendations; in my professional opinion it is likely that another service pipe (concealed in the space above) is leaking onto the ceiling.

I **recommend** that a ceiling access trap (approximately 400mm by 400mm) be installed and the void further inspected.

I **recommend** that the cause moisture entry be rectified and that this might be possible through epoxy injection. Upon completion of moisture entry prevention I **recommend** that the damaged ceiling be replaced

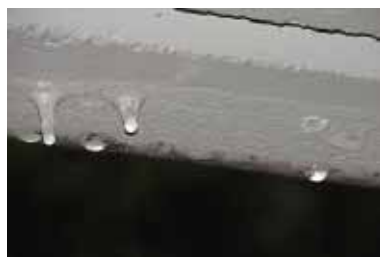
Photo No 24

Refer example Photo No24, which show very significant moisture staining in the slab soffit, which when moisture meter testing indicated very high moisture content.

Recommendations; in my professional opinion I consider that the waterproof membranes of both G.F balconies (over garbage rooms & carpark entry) are defective and require rectification. It is likely that the inadequate balcony tiling falls (by way of ponding) is also contributory to the problem.

I **recommend** that these balconies be dye flood tested and the location of leaks determined. Upon determination I **recommend** reinstatement of the waterproof membrane and improving the balcony tile falls.

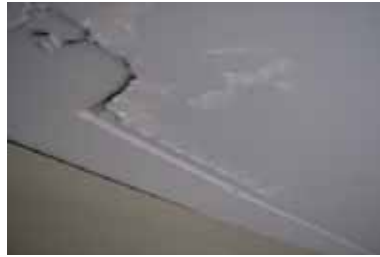
Photo No 25

Carpark entry slab soffit was inspected – **Refer example Photos No25** showing calcification stalactites, which have occurred as a result of long-term moisture gain in slab soffit over together with **water flow.** **Refer example Photos No25a** showing moisture related staining of the internal slab soffit edge.

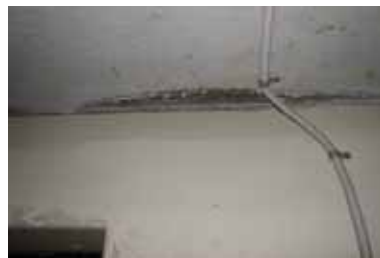
Photo No 26

Southern garbage room was inspected – **Refer example Photos No26 &27** which show very significant moisture staining in the slab soffit both at the internal and external edges, which when moisture meter tested recorded very high moisture content.

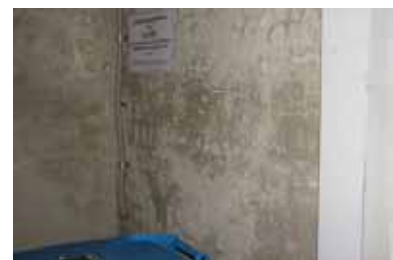
Photo No 28

Refer example Photos No28 &28a, which show very significant moisture staining and efflorescence in and lower the upper external wall, which when moisture meter tested recorded very high moisture content.

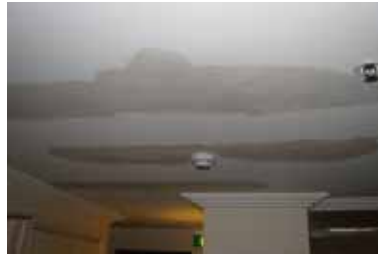
Photo No 37

Noted Defects; upper section of *unit separating walls* over units *G. 01, G. 02 & G. 03* entry were inspected and had evidence of various *service pipe, mech ventilation and/or cable penetrations*, which did not appear to have been adequately sealed for F. R. L. & S.T.C (or Rw). *Refer example Photos No 34- 37.*

Recommendations; I **recommend** that a fire engineer be engaged to comment further on the adequacy of vertical and horizontal fire separation issues.

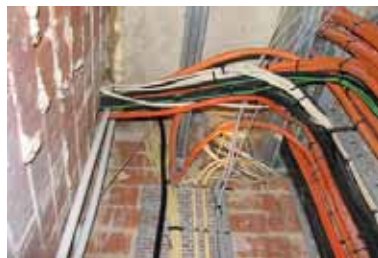
Photo No 39A

Noted Defects; various service pipe penetrations in upper separating walls did not appear to have been adequately sealed for F. R. L. - *Refer example Photo No39, 39a, 39b.*

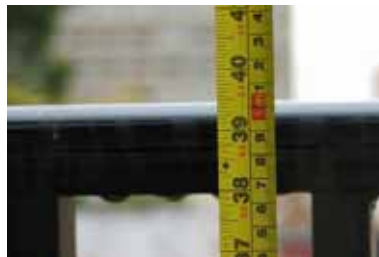
Photo No 63a (unit 302 West balcony balustrade)

2. **Unit 302 West balcony balustrade rectification** for compliance with the BCA as noted. Recommend other similarly built balcony balustrades also be checked for compliance and that this issue be taken up with Council and/or the Principal Certifying Authority (PCA).

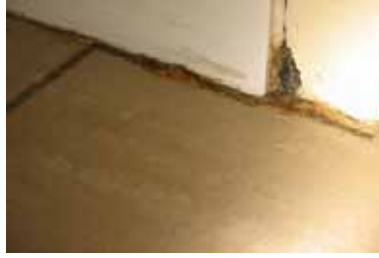
Photo No 71 (unit 302 shower)

3. **Unit 302 Bathroom** repairs as noted including **leaking shower area**. Suggest other showers be inspected for similar leaks e.g. refer **Photo No43**.

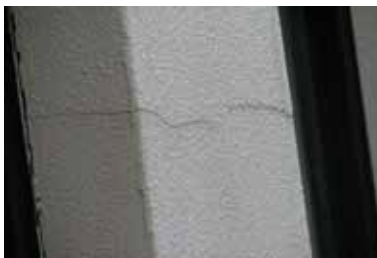
Photo No 76 (unit 107 drummy balcony render)

8. **Unit 107;** Rectify **falling damp** in balcony slab soffit and **defectively drummy** and cracked render.
9. **External Facade;** Potentially **significant remedial works required** to offset **moisture ingress behind protective external paint film** of the external facade walls, by sealing cracks and replacing drummy render, which had only be done after rectification of the above noted drummy render.

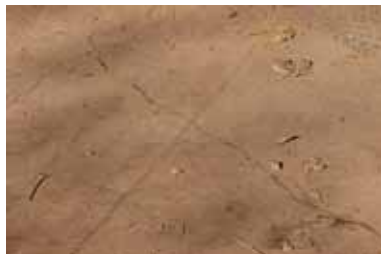
Photo No 90A

12. **Unit 302** internal and remaining noted repairs.
13. Suggest the Owners Corporation engaged a structural engineer to look at and report on noted cracking to the **SE lower height retaining wall**.
