**Common Area Building Survey Report  
Of**

**Levels P1 – Roof** (external of private lots)

**Elizabeth Bay**

**Strata Plan No XYZ**

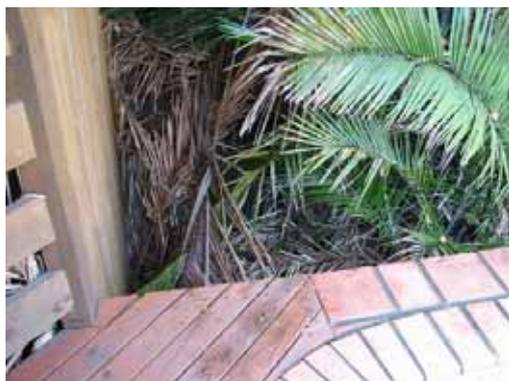
*Photo No 2*

*Refer Photo No2* of the *northern timber balustrade*, which is over 1000mm high and backs onto a significant fall height and incorporates horizontal rails, which could serve as *step-up zones*.

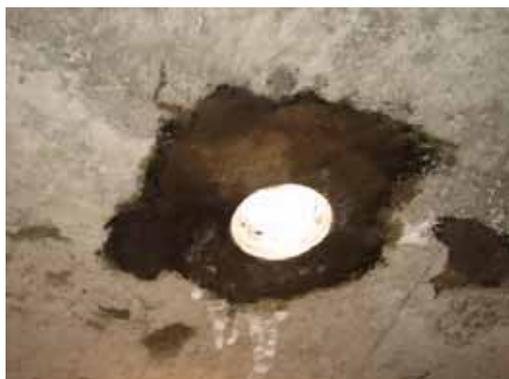
*Photo No 14*

**Refer Photo No14** showing a recently installed surface grated drain (not connected) at the SE corner of P2 slab.

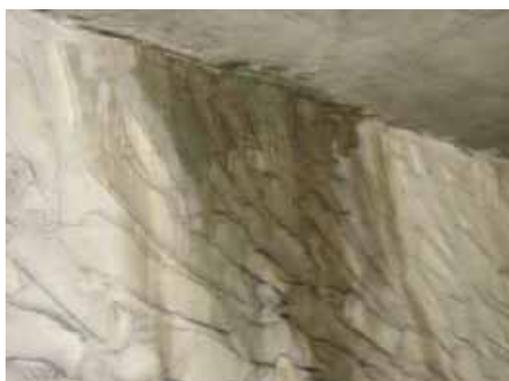
*Photo No 17*

**Refer Photo No17** showing evidence of *falling damp* down the *eastern external concrete wall* (at junction with slab soffit), which is located beneath an exposed and poorly drained area of P2 slab where excess surface water was pooling.

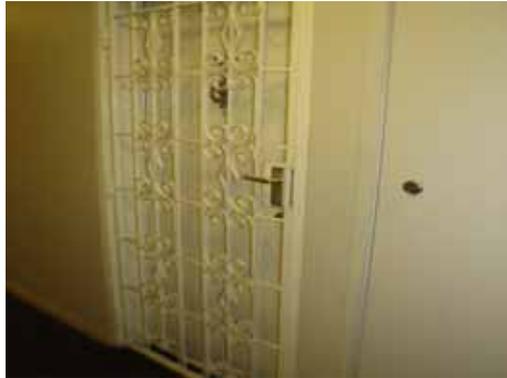
*Photo No 57*

Refer Photo No57 showing a lockable *security grille\door* in front of a unit entry fire door of which there are numerous examples.

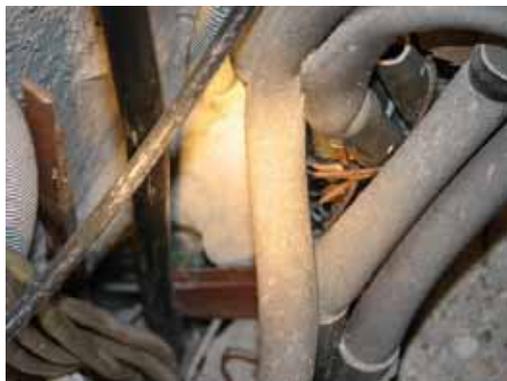
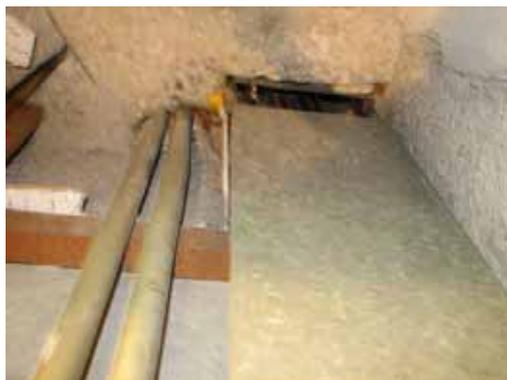
Many of the enclosures contain excess combustible materials – *Refer example Photos No58 – 58E*.

Numerous *floor slab penetrations* do not appear to have been adequately sealed for F. R. L. – *Refer example Photos No58 – 58E*.

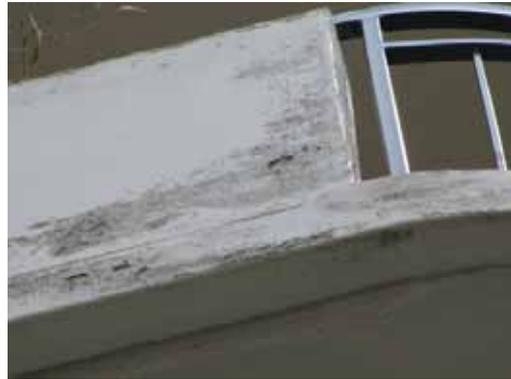
*Photo No 92*

**(Block C) Defects; rust related expansion spalling;** the following balconies had evidence of *moderate spalling* at the slab edges, which in my professional opinion is due to the rusting of balcony handrail supports embedded within the concrete slabs. *Levels 3 & 4 - Refer example Photos No92, 93 & 94*

**Priority Level 2; Recommend in conjunction with above works that a *structural engineer* be appointed to inspect and report on the noted *spalling and brick dislodgement* on the *rear elevation balconies* and to more closely inspect the *front elevation upper walls* (adjoining Levels 7 & 8 windows) which may require specialist hoisting equipment.**

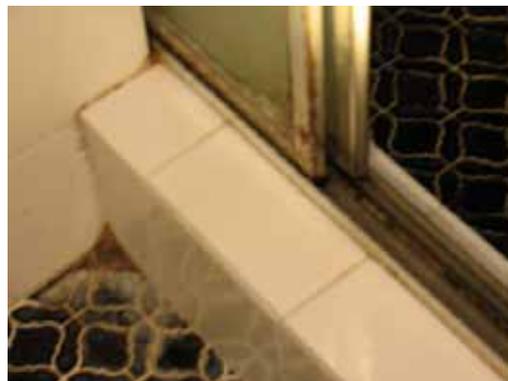
*Photo No 113*

Leaking Shower Recess; *Refer Photo No113* of the subject unit shower recess, which appears to be (based on my other private lot inspections) as originally constructed. The shower recess had some evidence of *leaks* through the hob and onto the main floor area – *Refer Photo No113*.

**Priority Level 3**; rectify moisture damaged paintwork to bathroom ceiling of **Unit 6B** and have remedial contractor ‘Megasealed Bathrooms’ provide a quotation for a possible repair methodology and associated warranty for the shower recess.

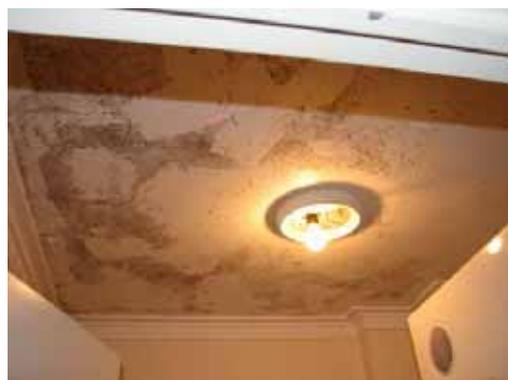
*Photo No 114*

The laundry ceiling has extensive and *very significant mould* and *condensate staining* (*Refer Photo No114*).
