Purpose of Report: *Post Renovation Building Defects Report*
Date of Inspection: 17th October 2005
Property Description: **4-5 Bed F.S Timber Framed Residence**
Address of Property: **Burrawang NSW**
Invoice No.
Client Name: Mr & Mrs. M
Building Consultant: Mr. Dominic Ogburn AMAIB Lic No BC 359
e-mail: info@accesspropertyservices.com.au
Office (02) 9798 5000 Fax (02) 9225 9656 Mobile 0418 865-663

On behalf of the client **Mr/s. M & L. M** I undertook a building survey of the subject **property** over one third of a day on **17/10/05**.

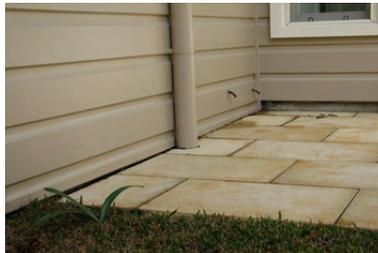
Photo No23

I'm advised by the owners that the builder had only broken up the concrete as recent rains have uncovered the walls of the tank - *Refer Photo No23*.

1. Break up and remove remaining *original concrete septic tank* and make good soil.
2. Paint *seal tops and bottoms of all doors*, as per manufacturers warranty requirements.
3. Install *rubber buffers* to all bathroom joinery doors drawers as per kitchen.
4. Miscellaneous Garage cupboard repairs.
5. Recommend raking out of solid grouted joints and installation of *sealant filled movement joints* in all *vertical tile corners and all wall/floor joints*, so as to minimize likely future differential movement cracking and expansion related delamination.
6. Miscellaneous minor window/ door repairs and make good *ceiling insulation* as noted.
7. Builder is to provide written confirmation that all *external house timber cladding* is CCA finger jointed treated pine, as specified.
8. Remaining items as noted.

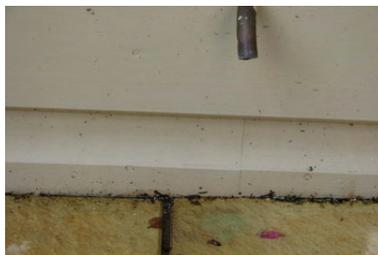
Photo No24

Refer example *Photos No 24 & 24 A* (of entry branded paving and adjacent external timber wall lining) showing the paving level at the eastern end has been built up and is partially concealing the external lower timber wall cladding.

8. Builder to reconstruct the *main entry paving* such that it does not embed and /or conceal any of the external cladding such that soft rot and/or undetected termite entry cannot occur.
