Purpose of Report: *Special Purpose (Damp) Partial Inspection Report*
Date of Inspection: 28th Decemeber 2005
Property Description: **2 Bed Split Level Attached Residence**
Address of Property: **Mullens St Rozelle**
Client Name: Mr AB C/- Hyde Park SA 5061
Building Consultant: Dominic. J. Ogburn AMAIB
e-mail: info@accesspropertyservices.com.au
Master Building Consultant
Office (02) 9798 5000 Fax (02) 9225 9656 Mobile 0418 865-663

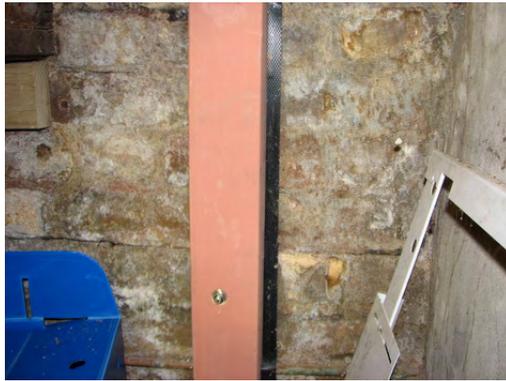
Photo No 11

Kitchen & Stairwell NW external Wall; removal of Kitchen cupboard skirting allowed moisture meter testing of the lower section of the NW brick wall (*Refer Photo No10*) which recorded high to very high damp. This damp continues across the same wall down into stairwell external wall (*Refer Photo No11*), which has lead to moisture migration into *timber stair* attached to this wall (*Refer Photo No11A*) and also into the *LGF NE wall (refer Photo No12 & 12A)*. Some section of the timber stair have a saturated content and if left unchecked will lead to soft rot deterioration and is a termite attractant. There is also evidence of moderate prior termite damage within a single stair riser (*Refer Photo No13*)

I was unable to adequately determine the exact cause of this moisture entry and recommend that further investigative work be undertaken
