Purpose of Report: Pre Purchase Building Property Inspection
Date of Inspection: 17.5.2006
Property Description: 5 Bed Two Storey F.S Residence
Address of Property: Bellevue Hill
Client Name: Mr DW
Building Consultant: Building Consultant Dominic. J. Ogburn AMAIB Lic No BC 359
e-mail: info@accesspropertyservices.com.au
Office (02) 9798 5000 Fax (02) 9225 9656 Mobile 0418 865-663

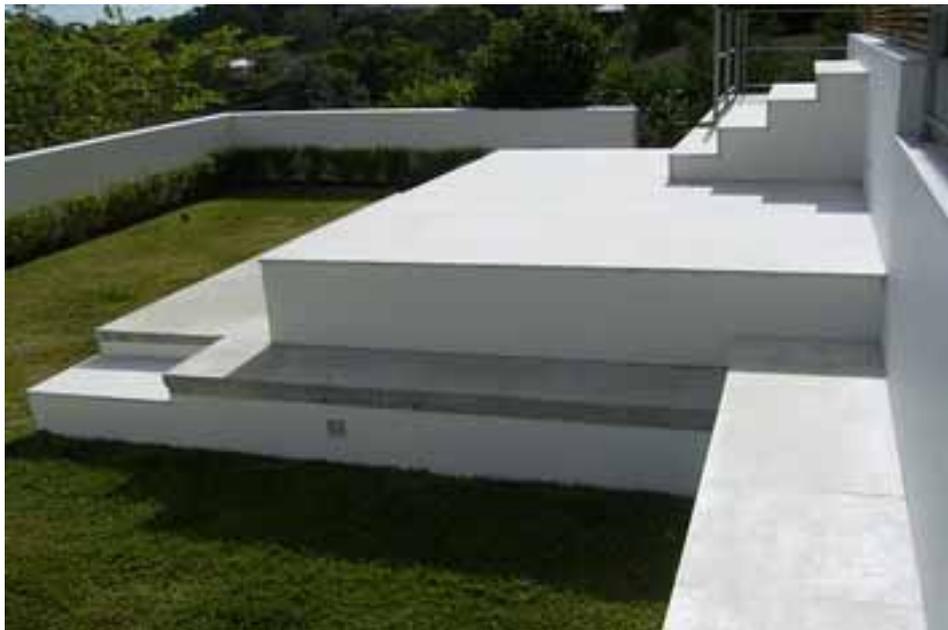
Photo No9

Rear courtyard; this tiled area appears to incorporate adequate falls\drainage and generally appeared quite sound. *Refer Photo No9* showing the rear courtyard steps which the client requested I provide an indicative budget estimate to remove.
