**Partial External Facade
Building Survey Report**

Levels G.F – Lower Penthouse (& two private lots)

ABC Apartments
Strata Plan No 70XXX

Darlinghurst

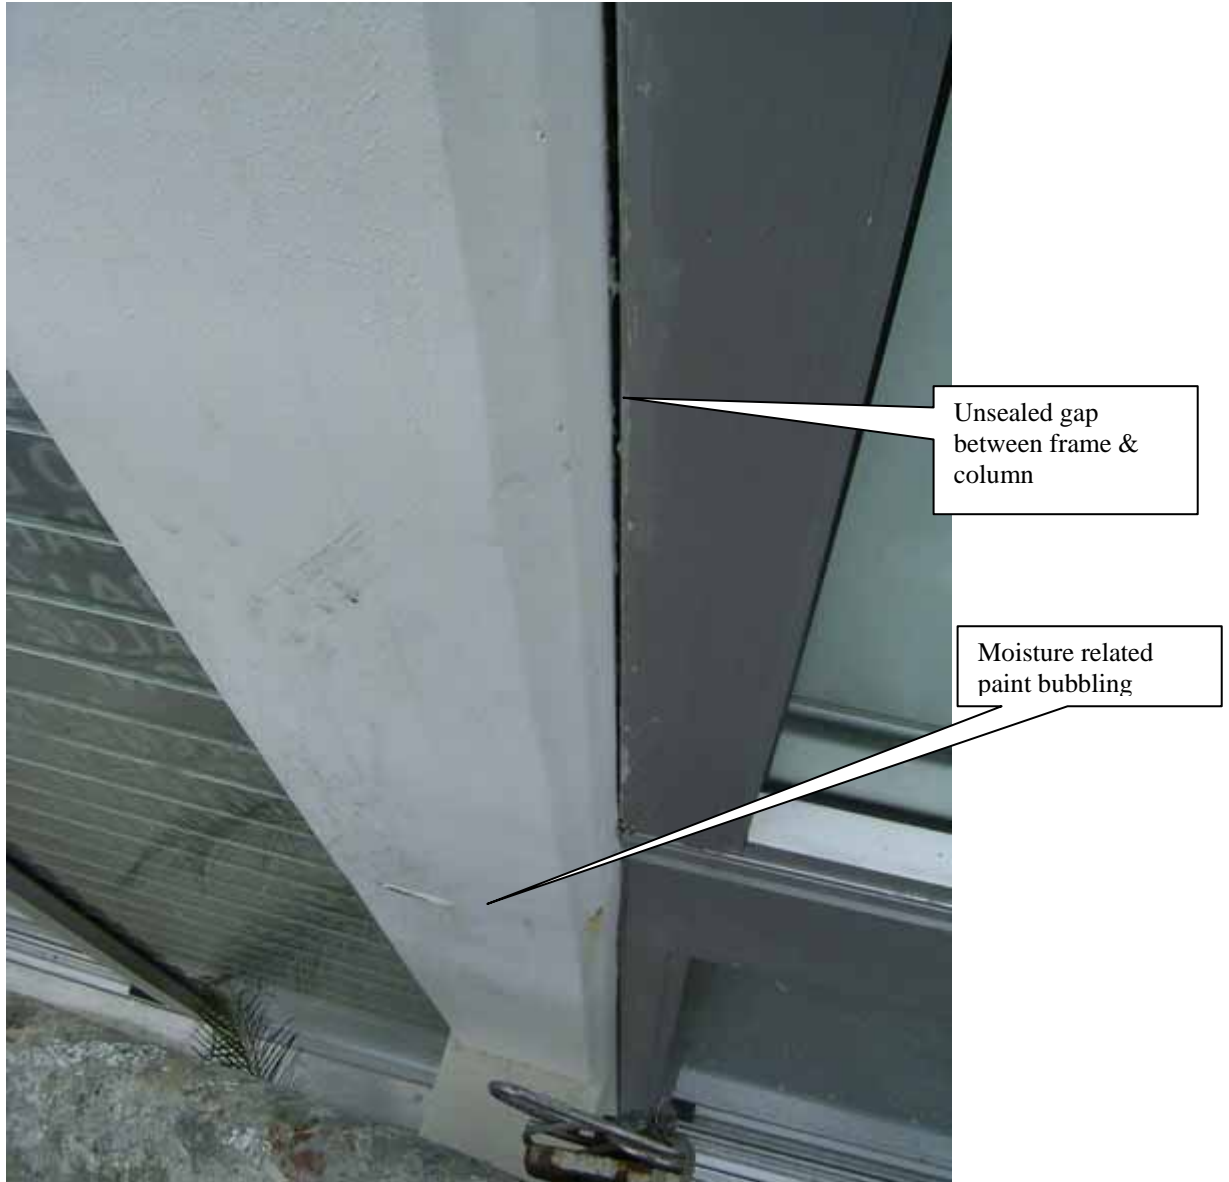
Photo No50

1.96 *Lower eastern central facade; Refer Photo No 50 showing evidence of moisture related paint film bubbling on a lower external concrete column.*

Refer Photos No50 & 51 showing lack of external storm moulds and/or sealant filling between the window frame and adjoining concrete column.
