Partial Building Defects Survey Report

Basement & units 1,2,3,5,6 & 7 (bathrooms & balconies)

Rose Bay

The Owners Corporation
Strata Plan No 67XXX

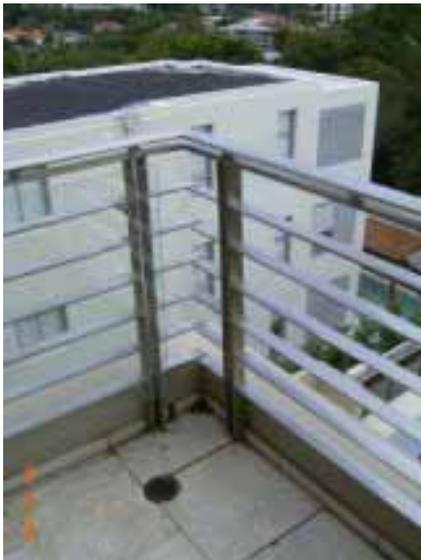
Example Photo No 42

The stainless steel *balustrading* incorporates *horizontal rails with some 110mm gaps between* each from bottom to underside of balustrade handrail (Refer example Photo No 42 below). The SW end balustrade (>4m above the surface beneath) incorporates a glass cover panel in front of these rails, which prevents climbing however, in my professional opinion the *western corner* section of this balustrade is contrary to the requirements of *BCA Clause 2.16 (g) (ii) (B)* as the existence of the horizontal rails *facilitates easy climbing to a potential fall of more than 4m to surface beneath*.

Recommend that a copy of this report be provided to the project PCA (Woollahra Council) and that they be requested to formally request (by issuing a letter of intent) the vendor rectify all non-compliant handrails and associated structures to achieve a minimum compliance with the BCA requirement to prevent balustrade climbing, which will likely involve installation of safety cover glass panels.

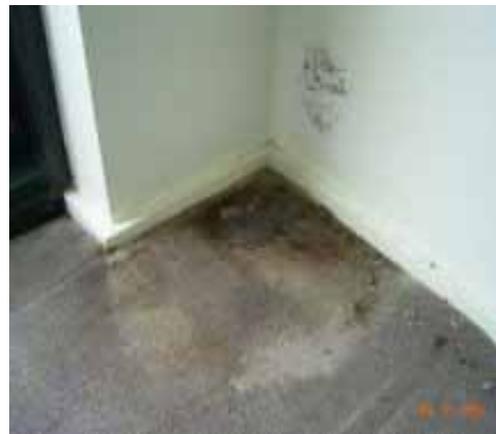
Example Photo No 43

Bed 3; *Extensive moisture related staining noted to the carpet* and lower wall at the western corner together with *very high moisture content in the lower walls* adjacent to external door (*Refer example Photo No 43*).

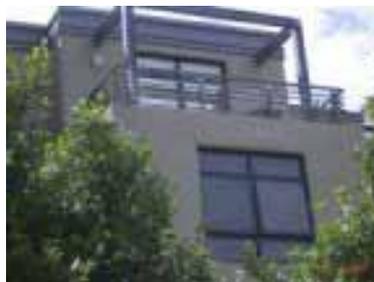
Photo No63

Bed 2 SE Terrace Noted Defects; *Refer Photo No63* (below) showing evidence of moisture related efflorescence and partially cracked render on *SE external face external face of this terrace*. Refer also prior comments under *Unit 2 Paragraphs 3.92 & 3.95* of this report.

Some destructive investigate of concealed elements (such as lower wall flashings and weep holes is required to determine requisite remedial works and rectify cause of and rectify cause of moisture gain within noted lower external wall/s.
