Common Area Building Survey Report
Of
Levels Basement – Roof (parts of three private lots)

North Sydney

The Owners Corporation
Strata Plan No XYZ5X

Prepared By
Access Property Services Pty Ltd

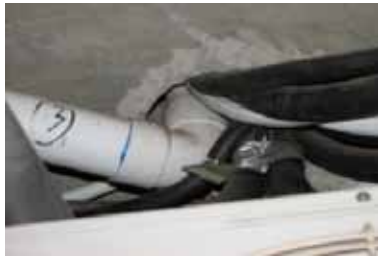
Photo No 1

Refer example Photo No1 at the end of car space No 304.

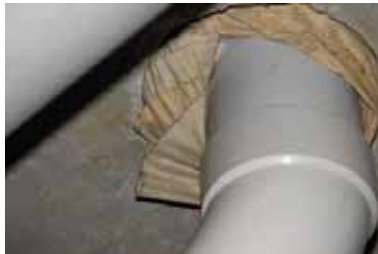
Photo No 2

Refer example Photo No2 at the end of car space No 105, which has been sealed with cardboard. 50 mm diameter waste pipe over Main garage entry

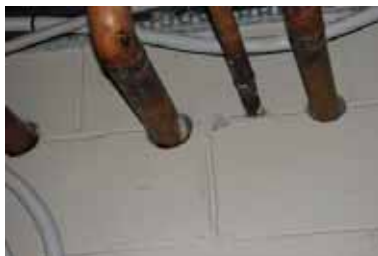
Photo No 3

Refer example Photo No3 of various redundant 20mm diameter penetrations at the southern end of car space No 305.

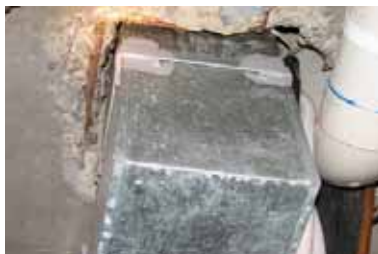
Photo No 4

Large mechanical **ventilation duct penetration** in slab soffit opposite basement lift lobby— **Refer example Photo No4.**

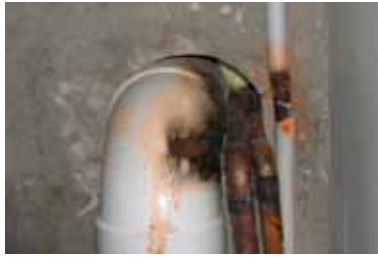
Photo No 5

100 mm diameter **PVC pipe penetration** in slab soffit opposite basement lift lobby — **Refer example Photo No5.**

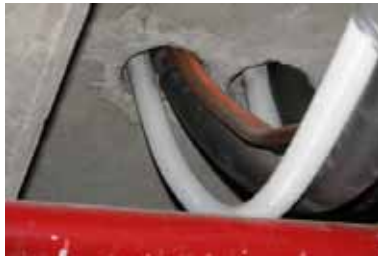
Photo No 6

Multiple **electrical cable penetrations** in slab soffit over car space No 302— **Refer example Photo No6.**

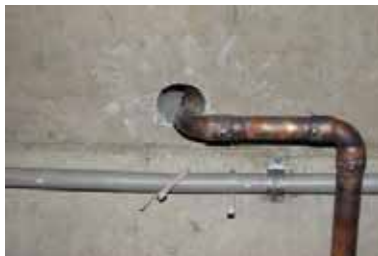
Photo No 7

Copper water pipe penetration in slab soffit outside main switch room— **Refer example Photo No7.**

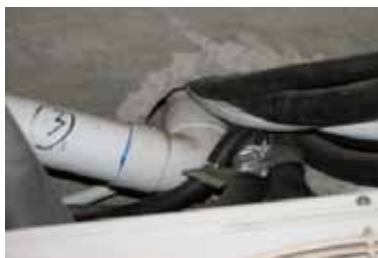
Photo No 8

Various **A/C condensate and service lines** in slab soffit adjacent to lift—**Refer example Photo No8**

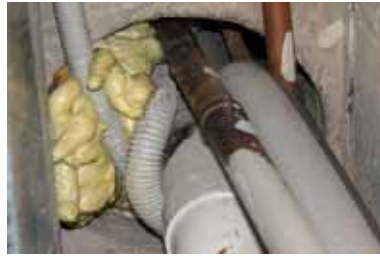
Photo No 9

Large roof slab penetration (partly foam filled) at southern end of car space 202. —**Refer example Photo No9**

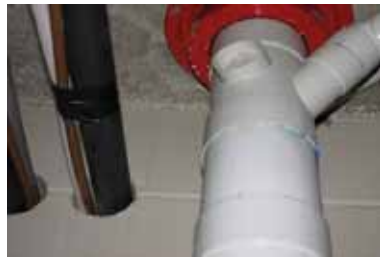
Photo No 10

Refer example Photo No10 of various **electrical cable penetrations** in the upper separating wall at the southern end of car space No 304.

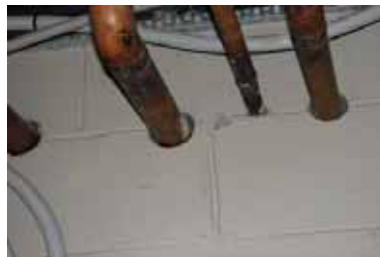
Photo No 11

Various 50 mm diameter **copper pipe penetrations** in the upper separating wall at the southern end of car space 106 — **Refer example Photo No11.**

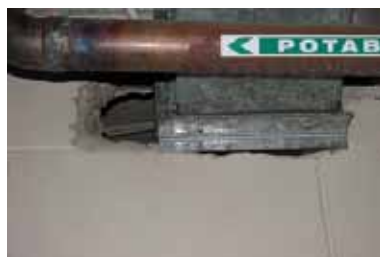
Photo No 12

Large mechanical **ventilation duct penetration** in the upper separating wall at the southern end of car space 106 — **Refer example Photo No12.**

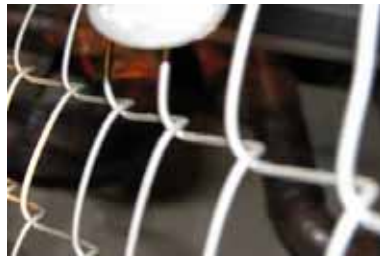
Photo No 13

Refer example Photo No13 of various **electrical cable penetrations** in the upper separating wall at the northern end of car space No 102.

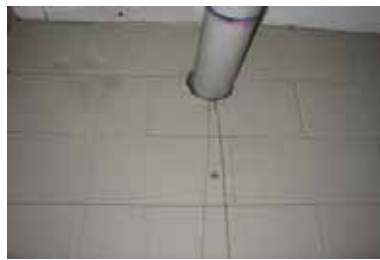
Photo No 14

Noted Defects; 100mm diameter pipe at western end of car space **No 207** is significantly **leaking Refer example Photos No14 & 14a.**

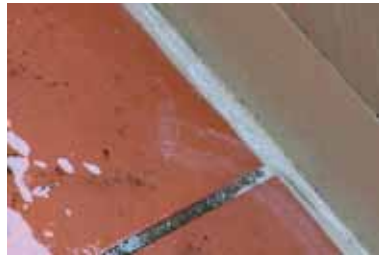
Photo No 19A

New white sealant can be seen in the **example Photos No19 & 19a of both these balconies.**

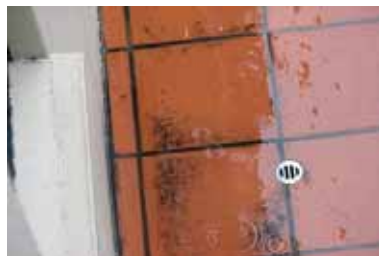
Photo No 20

Additionally there was evidence of the very **significant ponding** occurring (**Refer example Photo No22**) on both the balconies not least of which because they only incorporate a small 50mm central drain – **Refer example Photo No20 &21.**

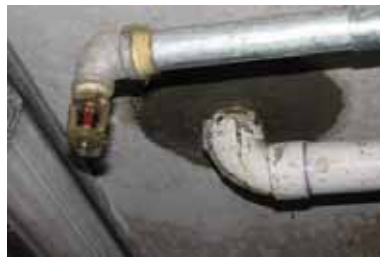
Photo No 23

Noted Defects; Northern garbage room was inspected and **a significantly leak** was apparent in and around 50mm stormwater drain pipe (serving balcony above) – **Refer example photo No23**

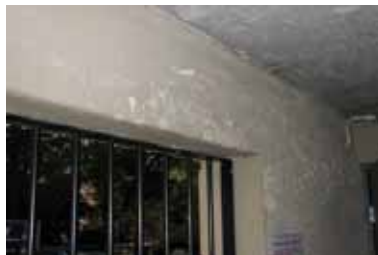
Photo No 24

Refer example Photo No24, which show very significant moisture staining in the slab soffit, which when moisture meter testing indicated very high moisture content.

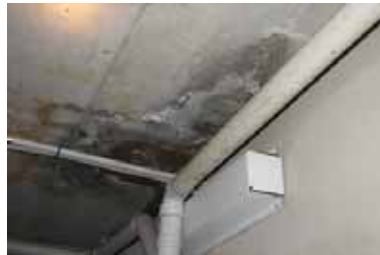
Photo No 26

Southern garbage room was inspected – **Refer example Photos No26 &27** which show very significant moisture staining in the slab soffit both at the internal and external edges, which when moisture meter tested recorded very high moisture content.

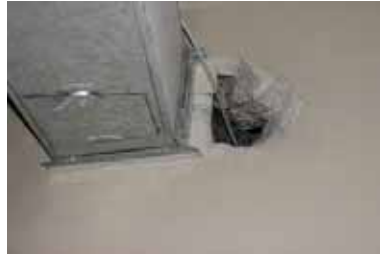
Photo No 30

Large mechanical **ventilation duct penetration** in upper northern separating wall has not been adequately sealed for F.R.L– **Refer example Photo No30.**

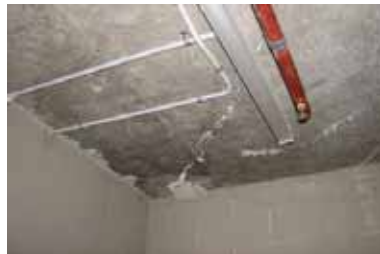
Photo No 31

The slab soffit over same as evidence of prior moisture leaks (evidence by calcification staining) and prior epoxy injection remedial works. Moisture meter testing of the roof slab revealed normal readings. — **Refer example Photo No31.**

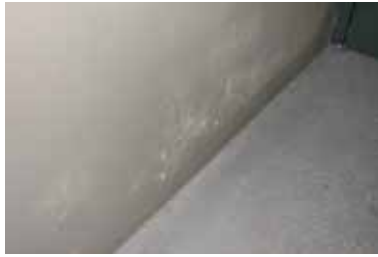
Photo No 32

Noted Defects; *Refer Photos No32* showing evidence of **moisture related efflorescence and damp** staining in the **lower southern external wall** between basement and G.F Level.

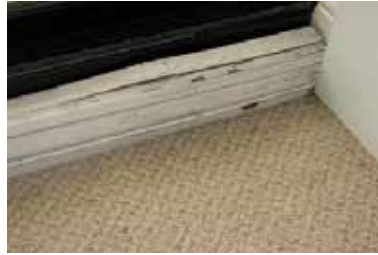
Photo No 54

Noted Defects; *Refer Photo No54* showing evidence of prior moisture related swelling in the **Sitting Rm MDF skirting** below external sliding door, which the owner-advised me occurred due to previous water entry from the outside (builder rectified) however the builder has never replaced the moisture damaged skirting *Refer Photo No55* showing peaking in **Dining Rm carpet** which in my opinion has occurred due to lack of leveling of the structural sheet flooring beneath and is causing accelerated wear in the carpet. There was further evidence of inadequate floor fixings as movement in the flooring was apparent in this area also. *Refer Photo No56* showing evidence of prior moisture related damage to the **Study window** sill reveal, which the owner-advised me occurred due to previous water entry from the outside (builder rectified) however the builder has never rectified the moisture damaged paint.

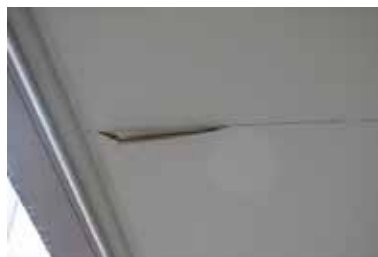
Photo No 57

Refer example Photo No57 showing evidence of with **moisture related** paint film delamination on the **eaves lining**, possibly associated with water entry from the roof over.

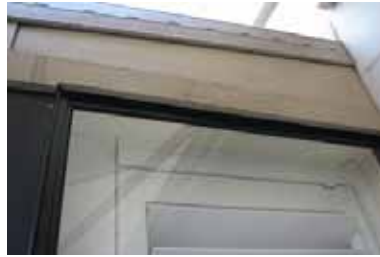
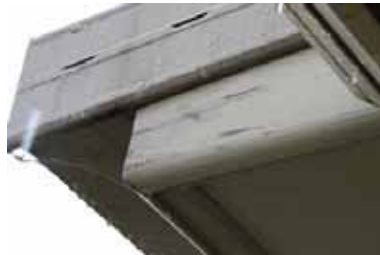
Refer example Photo No58 & 59 showing evidence of moisture related paint film deterioration of a Sitting Rm **timber trim and exposed fascia**, which I consider has occurred due to poor detailing of a drip edge and lack of adequate protection.

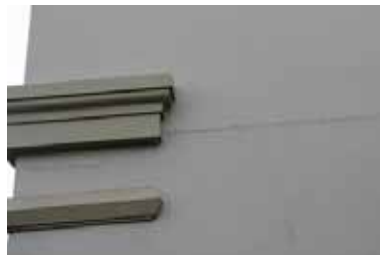
Photo No 60

Evidence of minor to **moderate horizontal cracking** in the external render and protective paint-film, which is likely, is allowing moisture in behind the paint-film, *Refer example Photo No60*.

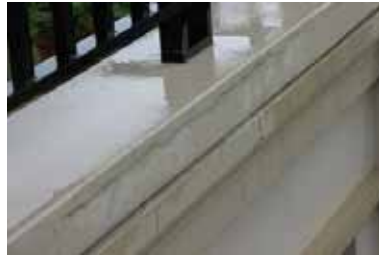
Photo No 63

Noted Balcony Balustrade Defects; Refer example Photos No63 & 63a showing the balustrade hob and balustrade, which shows a lower rendered brick balustrade type wall having a height of <500mm (above balcony FFL and as measured in three separate locations) and incorporating a horizontal ledge, with an aluminium balustrade handrail atop this.

Noted Defects; Refer example Photo No63, 65 showing external northern end of this **balcony hob edge** and evidence of minor to moderate cracking and drummy render and external moulding, around this area, together with moisture related paint film deterioration.

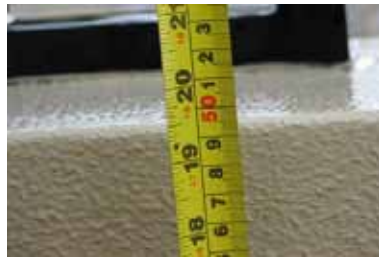
Photo No 63a (unit 302 West balcony balustrade)

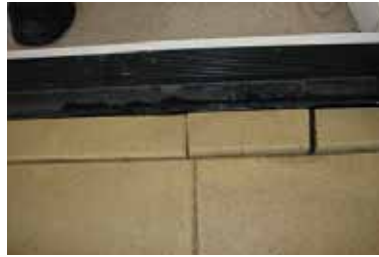
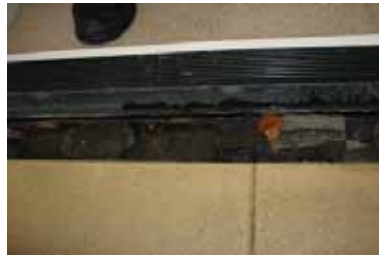
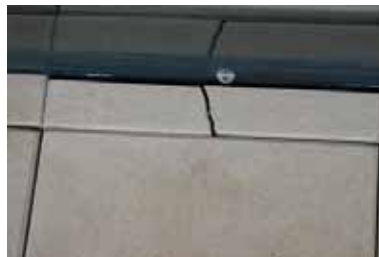
Refer example Photos No66, 66a & 66b showing **No2** off significantly displaced and **cracked pavers** at base of Study door, which has occurred due to the lack of adequate rubber supports beneath same.

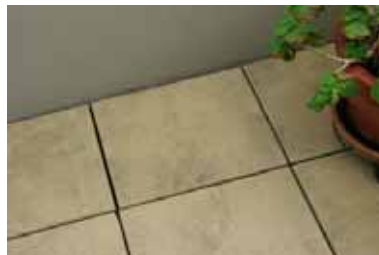
Photo No 67

Refer example Photo No67 showing a displaced pavers at NW balcony corner, which has occurred due to the lack of adequate rubber supports beneath same.

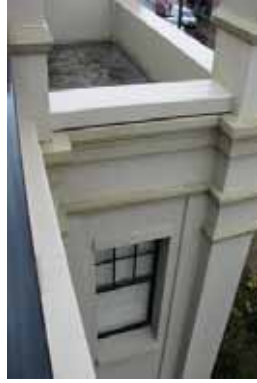
Photo No 68

Refer Photo No68 showing a flat roof (from this balcony) ponding of water and what appears to be a **delaminated water proof membrane**.

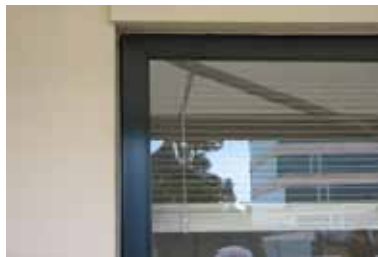
Photo No 69

Refer Photo No69 showing the aluminium **Study exit door** which the owner advises me is binding on door jamb due to thermal expansion.

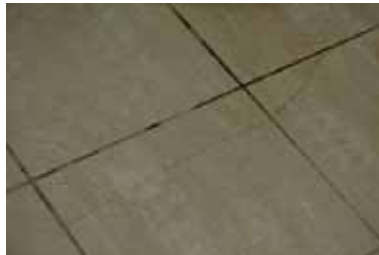
Hairline **cracking** is apparent to approx No2 off wall and No2 off floor **tiles - Refer Photos No74**

Photo No 74 (unit 302 cracked bathroom tiles)

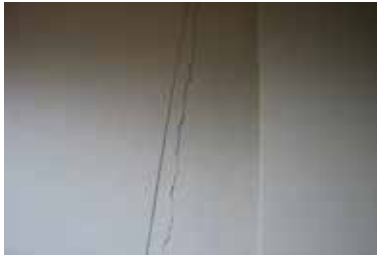
Refer Photos No76 showing minor to **moderate vertical cracking** in the external render, which I'm advised by the owner continues in the balcony over. The render around this crack was significantly **drummy**.

Photo No 76 (unit 107 drummy balcony render)

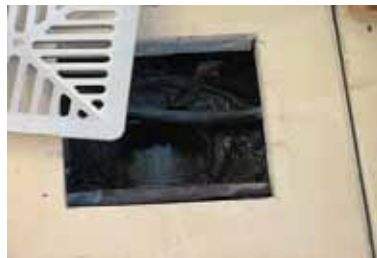
The owner of the subject unit advised me that the builder was still undertaking remedial works to the balcony **waterproof membrane** – **Refer example Photo No78 & 78A** and that these works were incomplete.

Photo No 78A (Unit 301 west balcony)

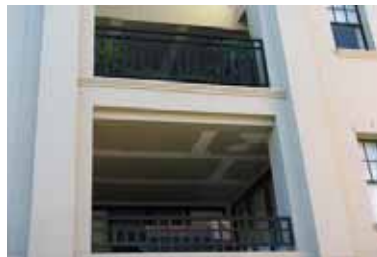
There was evidence of balcony ceiling replacements noted on two balconies beneath unit 301 as seen in **example Photo No79**.

Photo No 79 (repaired balcony ceilings below Unit 301)

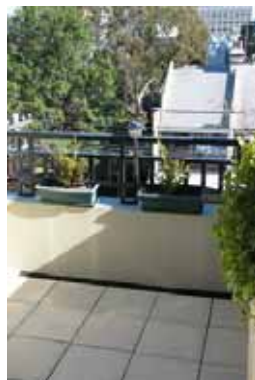
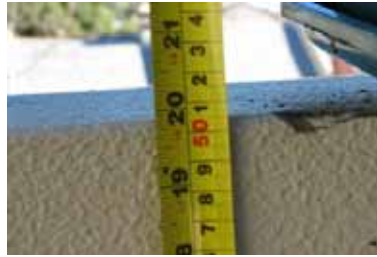
Noted Balcony Balustrade Defects; Refer example Photos No 80 & 80A of a NW **balustrade hob and balustrade**, which shows a lower rendered brick balustrade type wall having a height of **<505mm** (above balcony FFL and as measured in a central location) and incorporating a horizontal ledge, with an aluminium balustrade handrail atop this.

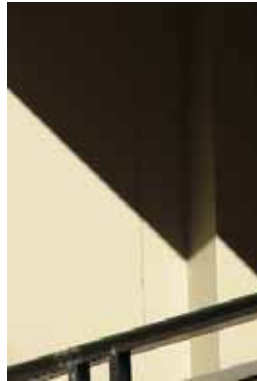
Photo No 85

Noted Defects; Refer example Photo No85, which shows **moderate vertical cracking** in external wall render, as previously noted under the unit 107 balcony section of this report, continues in the same wall of the balcony beneath (i.e. crack continues over at least three floors).

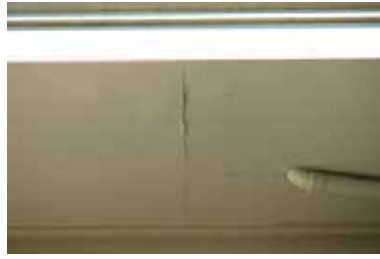
Photo No 87

Refer Photo No87 showing evidence of **moisture related damage** to a ceiling soffit lining of second-floor unit balcony (bulging ceiling lining).

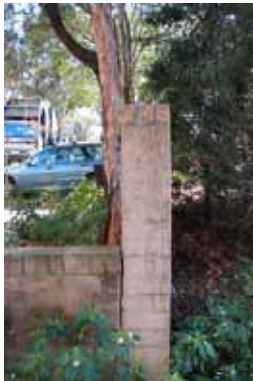
Photo No 90 (SE retaining wall)

Refer Photos No90 & 90a of minor to **moderate cracking and slight rotation** in the lower height brick **retaining wall** at the SE corner of the property. I'm not a structural engineer and was unable to determine the exact cause of cracking and rotating which could be related to settlement/movement and/or tree root intrusion.

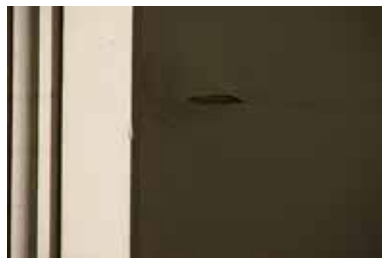
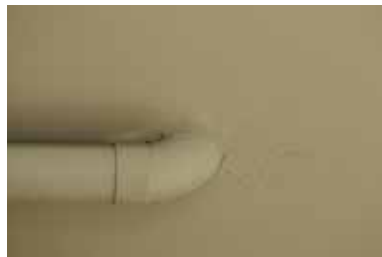
Photo No 93

Refer Photo No93 & 93a showing evidence of **moisture related damage** to a ceiling soffit lining of first-floor forward unit balcony (cracked ceiling lining and moisture related paint film bubbling).

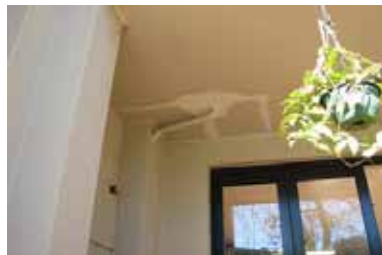
Photo No 94

Refer Photo No94 showing evidence of **moisture related damage** to a ceiling soffit lining of third-floor forward unit balcony (moisture related paint film bubbling around 100 mm diameter drain pipe).

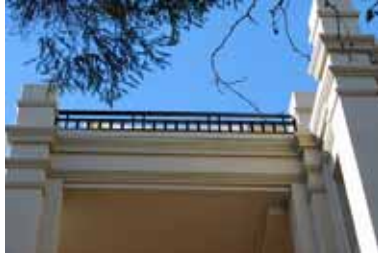
Photo No 95

Refer Photo No95 showing evidence of **patched** ceiling soffit lining of G.F forward unit balcony (over Thai restaurant), which has not been painted.

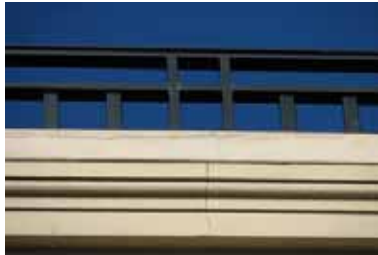
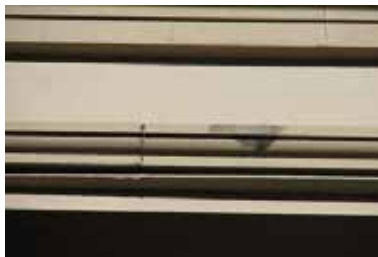
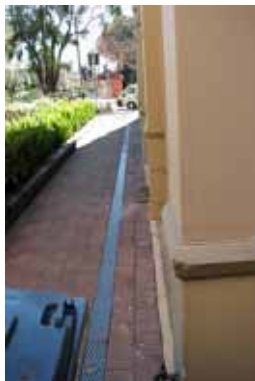
Photo No 96

Refer example Photo No96 & 96A showing evidence of **minor to moderate cracking** in the external **render** of uppermost roof balustrade wall, and which appears to be **drummy** and is likely to be permitting unwanted moisture entry in behind the paint film. **Refer example Photo No97** showing significant cracking any external moulding beneath the balustrade wall.

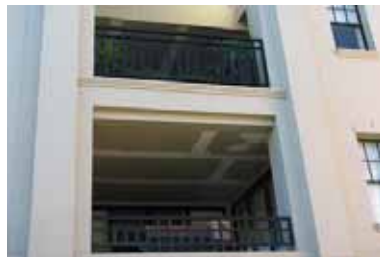
Photo No 99

Refer Photos No 99 & 99a showing very significant evidence of **moisture related damage** to a ceiling soffit lining of first-floor unit balcony above Convenience store (raised moisture related bulging in lining).

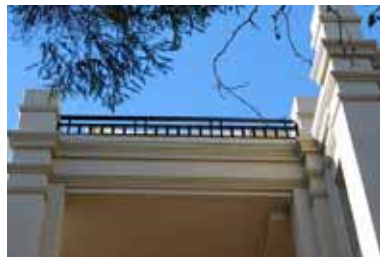
Photo No 100

Refer Photo No100 showing evidence of **repaired (replaced)** ceiling soffit linings of 1st Flr & 2nd Flr unit balconies (over Computer shop), which has not been painted.

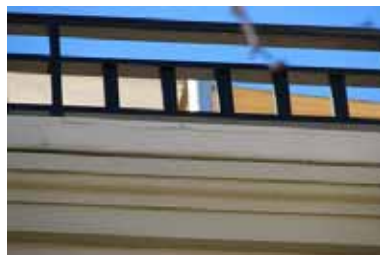
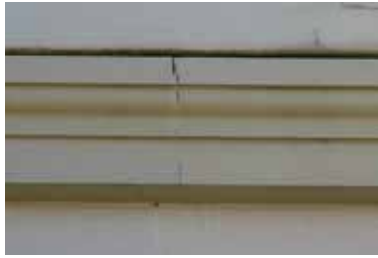
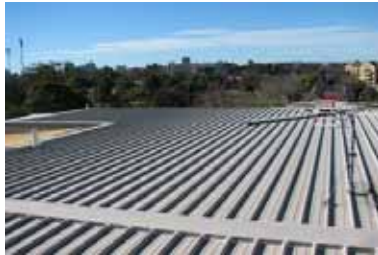
Refer example Photo No 101 & 101a showing evidence of **minor to moderate cracking** in the external **render** of third floor unit balustrade wall, which appears to be **drummy** and is likely to be permitting unwanted moisture entry in behind the paint film. **Refer example Photo No102** showing significant cracking any external moulding beneath the balustrade wall.

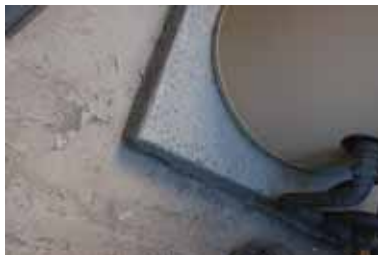
Photo No 103

The roof area does not incorporate any **fall arrest system** or perimeter safety handrail, which is a typical requirement under OH&S. **Refer Photo No103.**
